# Evaluation of Concentration and Distribution of PFAS from Selected QFES Facilities

Preliminary Site Investigation & Sampling, Analysis and Quality Plan

Client: Queensland Fire and Emergency Services

02-Apr-2019

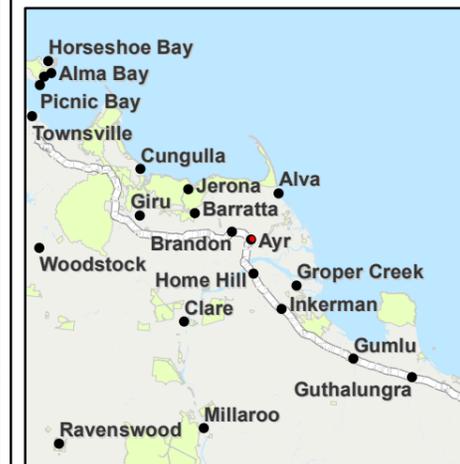
**Queensland Fire and Emergency Services (QFES)  
Ayr Site Layout and Suggested Sampling Locations  
Evaluation of Concentration and Distribution of PFAS from Selected QFES Facilities**

- Registered Groundwater Bores
- Proposed Monitoring Well
- Proposed Sediment/ Surface Water Sampling Location
- Proposed Surface Soil Sampling Location
- Drainage Pit
- Hydrant
- Drainage Line
- Concrete Spoon Drain
- Hydrant Water Mains
- Previously grassed areas potentially used for foam training exercises
- Site Boundary
- Cadastre

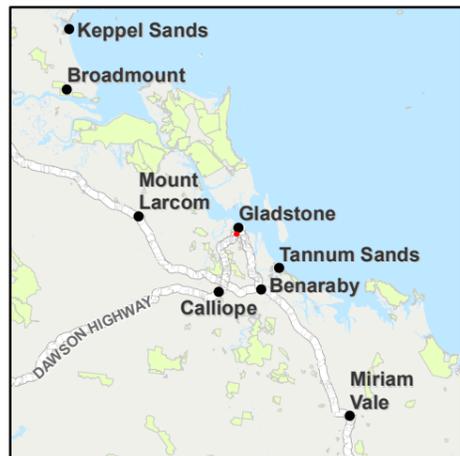
**Figure F6**

**Queensland Fire and Emergency Services (QFES)  
Gladstone Site Layout and Suggested Sampling Locations  
Evaluation of Concentration and Distribution of PFAS from Selected QFES Facilities**

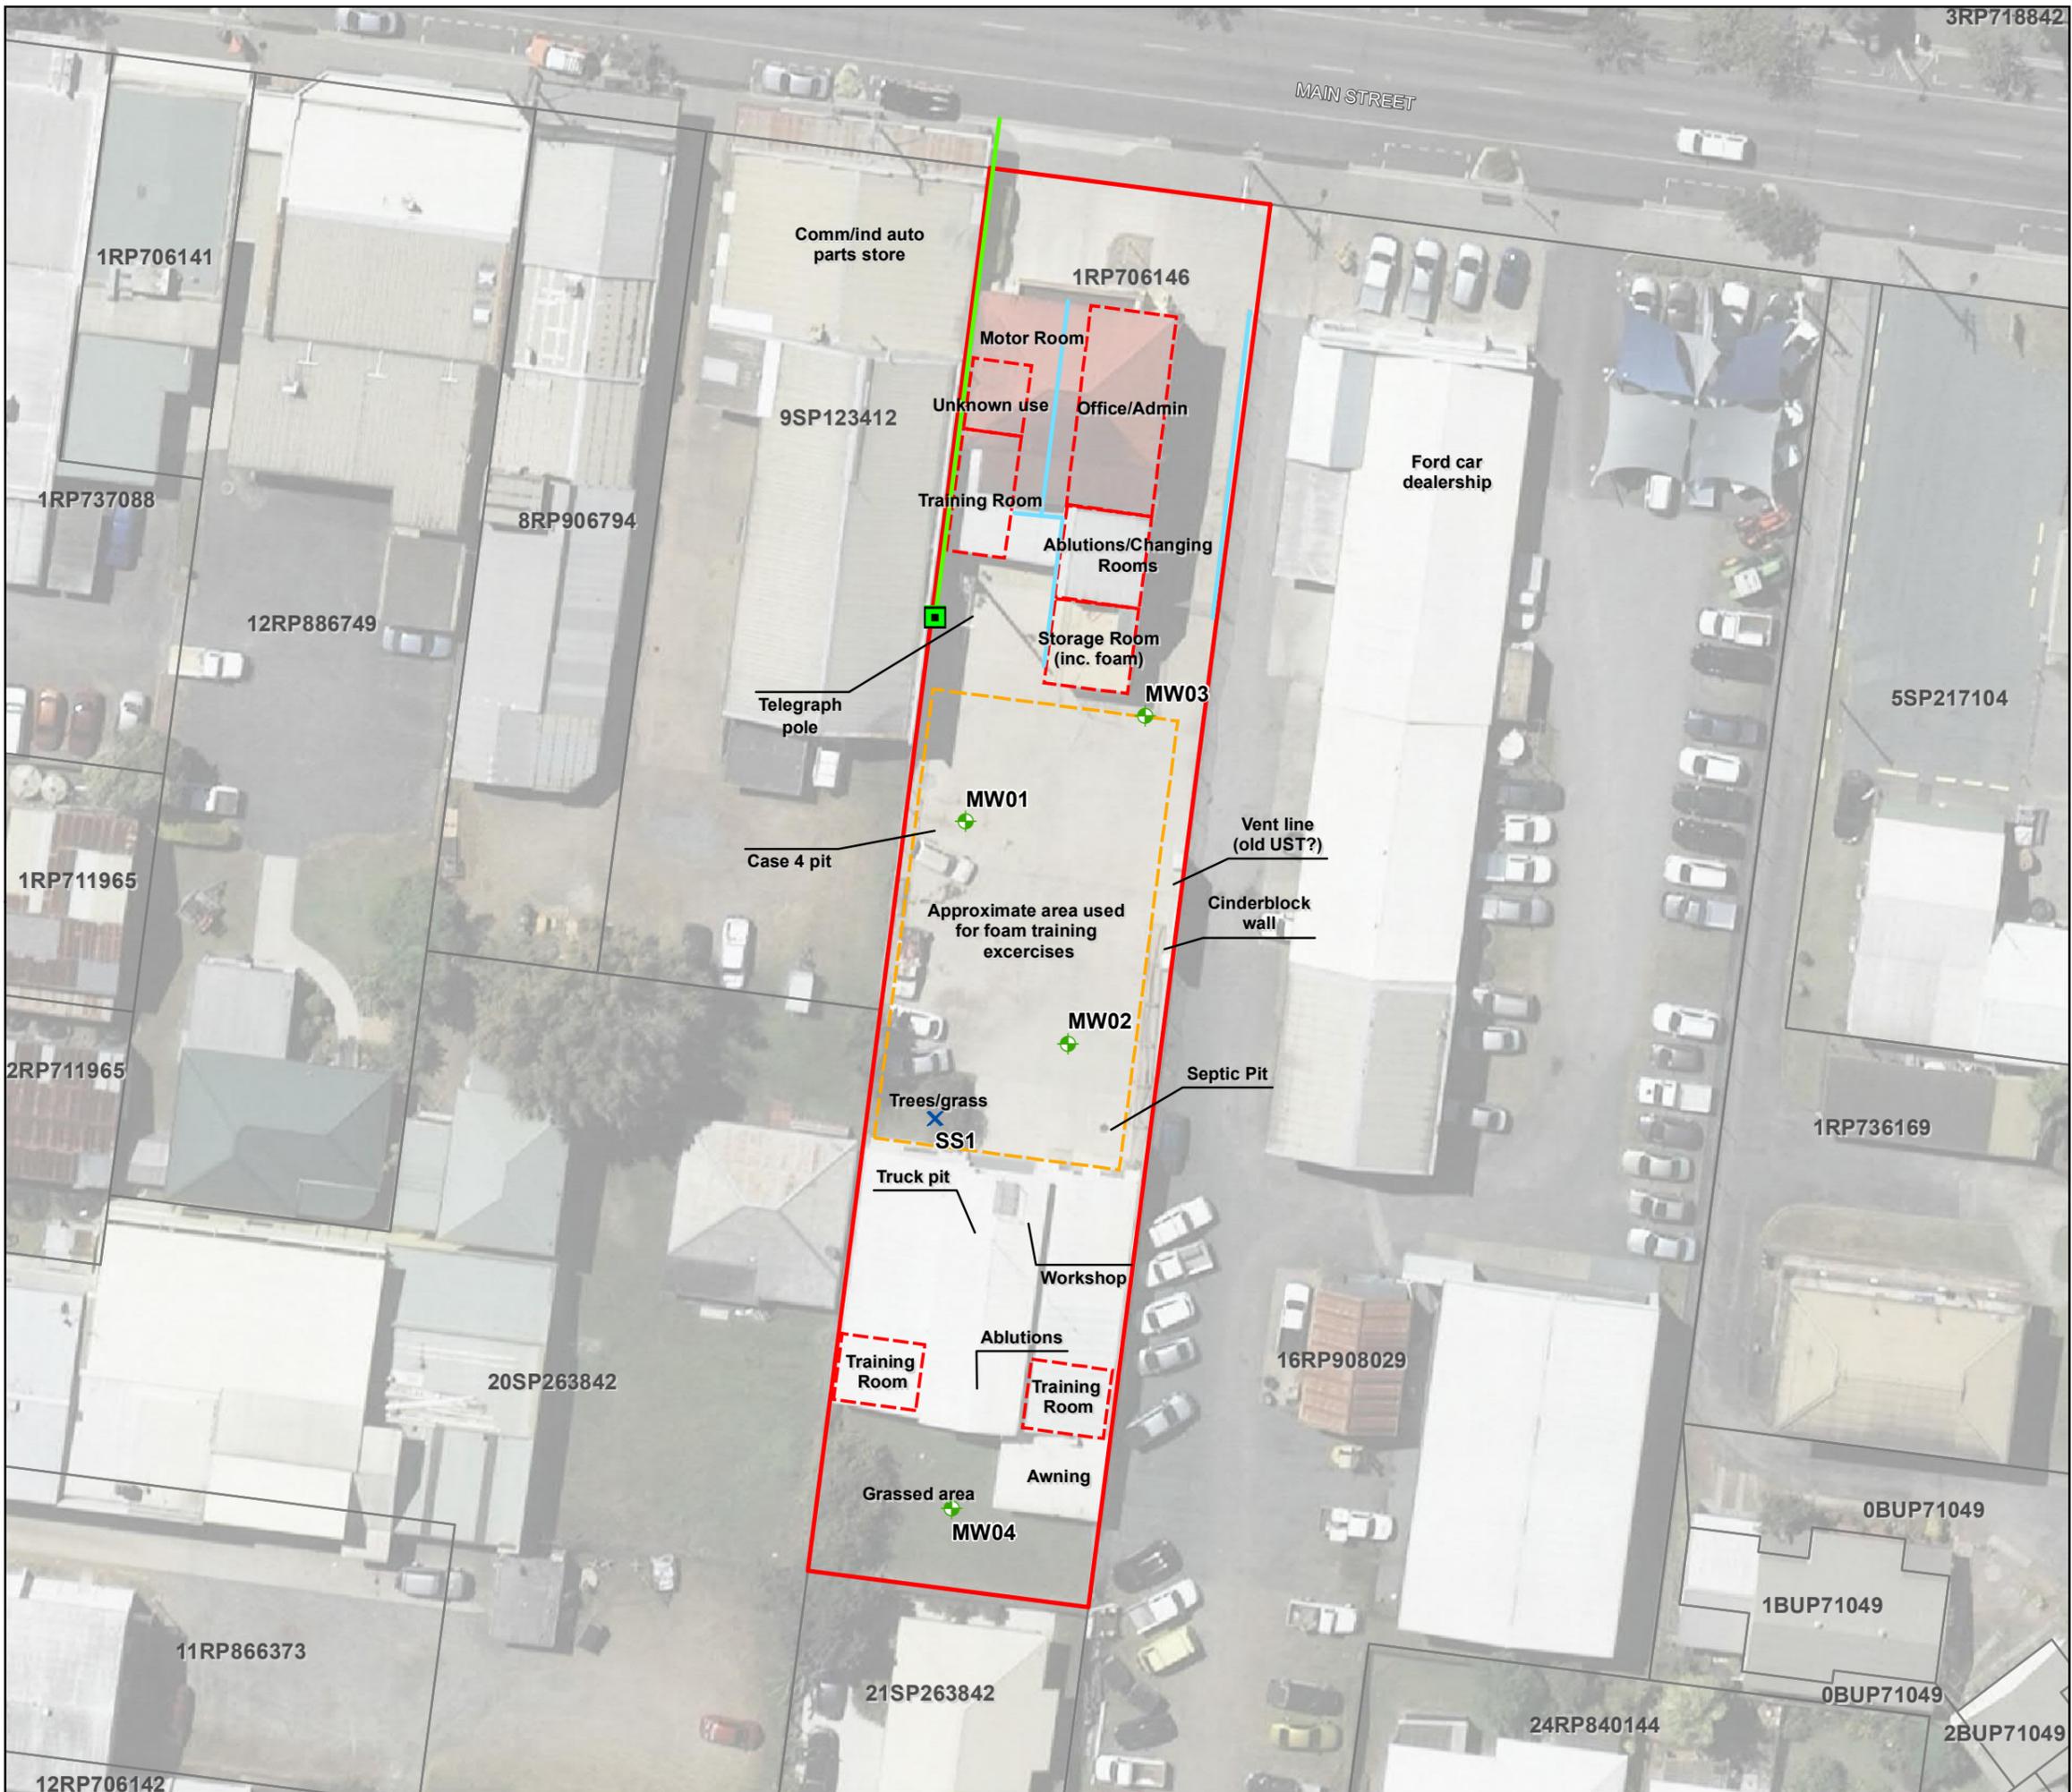
**Figure F10**

- Proposed Monitoring Well Sampling Location
- Proposed Sediment/ Surface Water Sampling Location
- Proposed Soil Bore
- Proposed Surface Soil Sampling Location
- Registered Groundwater Bores
- Hydrant
- Drainage Line
- Hydrant Water Mains
- Approximate area used for foam training exercises
- Site Boundary
- Cadastre

**Queensland Fire and Emergency Services (QFES)**  
**Prosperine Site Layout and Suggested Sampling Locations**  
 Evaluation of Concentration and Distribution of PFAS from Selected QFES Facilities

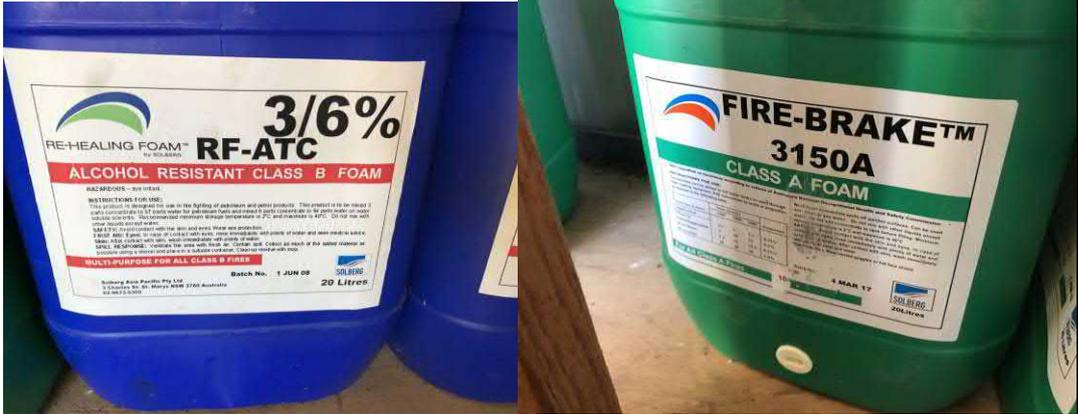
<b>Site Name:</b> QFES – Airlie Beach Fire Station	<b>Site Location:</b> 2495 Shute Harbour Road, Airlie Beach	<b>Date of Photograph:</b> 13/02/2019	<b>Project No:</b> 60595892
<b>Plate No. 1</b>

<b>Direction Photo Taken:</b> N/A			
<b>Description:</b> Class A and Class B Foams stored in storage shed midway along north-western site boundary.

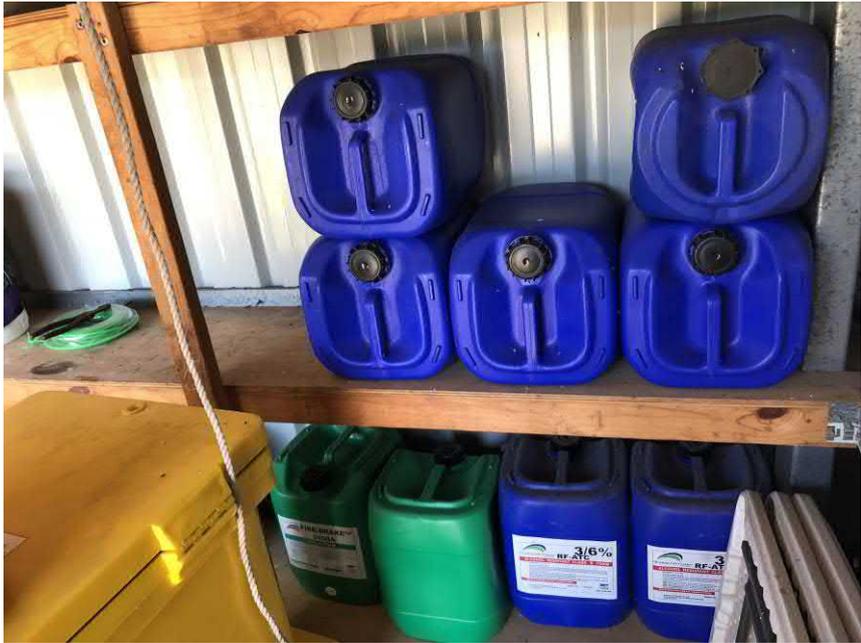
<b>Site Name:</b> QFES – Airlie Beach Fire Station	<b>Site Location:</b> 2495 Shute Harbour Road, Airlie Beach	<b>Date of Photograph:</b> 13/02/2019	<b>Project No:</b> 60595892
<b>Plate No. 2</b>

<b>Direction Photo Taken:</b> N/A			
<b>Description:</b> Storage of Class A and Class B Foam in foam storage shed midway along north-western site boundary.

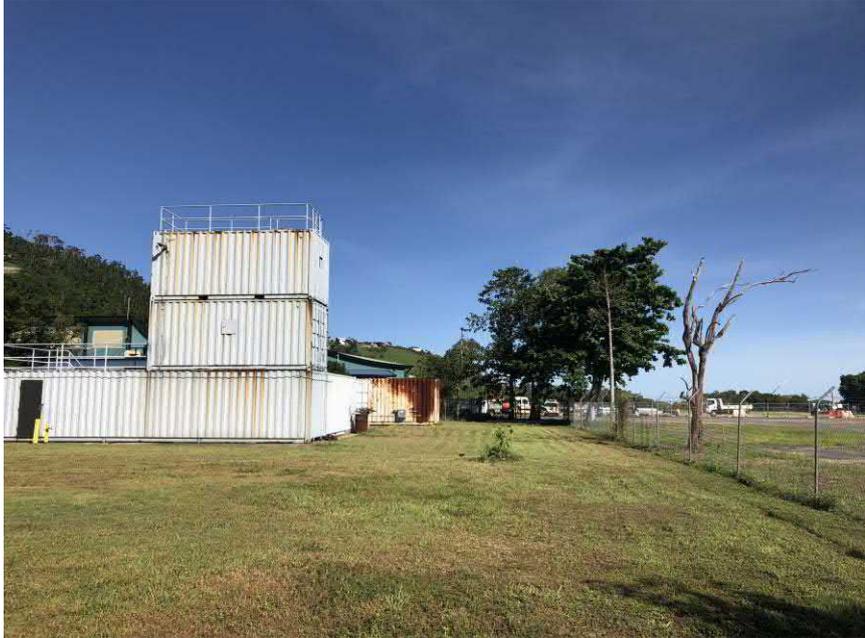
<b>Site Name:</b> QFES – Airlie Beach Fire Station	<b>Site Location:</b> 2495 Shute Harbour Road, Airlie Beach	<b>Date of Photograph:</b> 13/02/2019	<b>Project No:</b> 60595892
<b>Plate No. 3</b>

<b>Direction Photo Taken:</b> North-west			
<b>Description:</b> Stacked containers used for smoke training in foreground. A single container used for heat training in background.

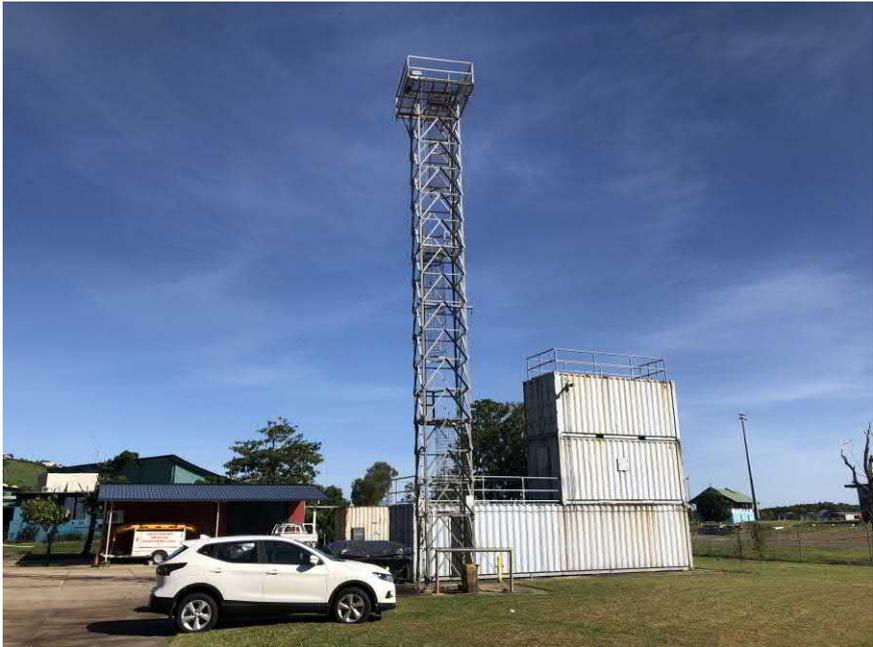
<b>Site Name:</b> QFES – Airlie Beach Fire Station	<b>Site Location:</b> 2495 Shute Harbour Road, Airlie Beach	<b>Date of Photograph:</b> 13/02/2019	<b>Project No:</b> 60595892
<b>Plate No. 4</b>

<b>Direction Photo Taken:</b> North			
<b>Description:</b> Training tower located in the centre of the site. The workshop is visible in the background.

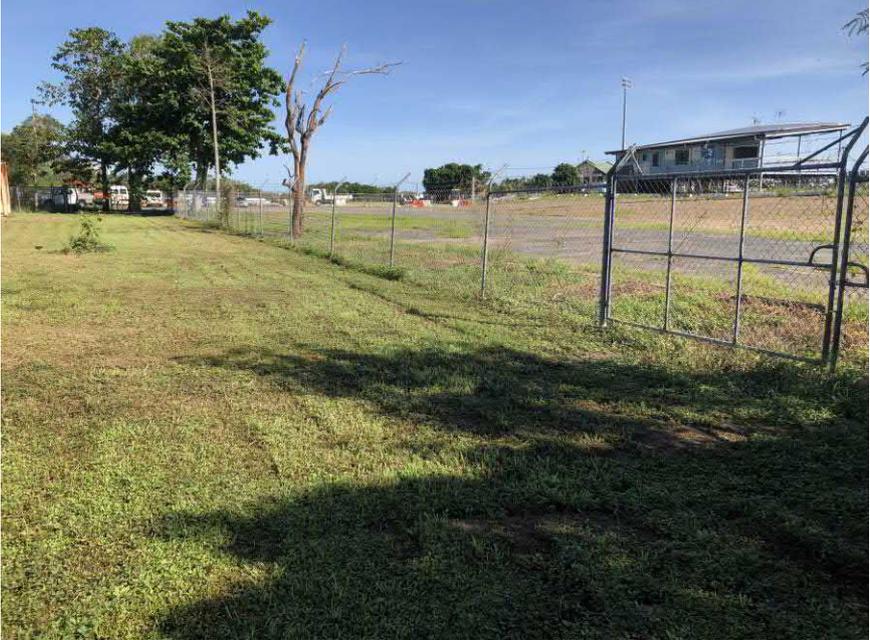
<b>Site Name:</b> QFES – Airlie Beach Fire Station	<b>Site Location:</b> 2495 Shute Harbour Road, Airlie Beach	<b>Date of Photograph:</b> 13/02/2019	<b>Project No:</b> 60595892
<b>Plate No. 5</b>

<b>Direction Photo Taken:</b> North			
<b>Description:</b> Surface depression location in the north-east corner of the Property.

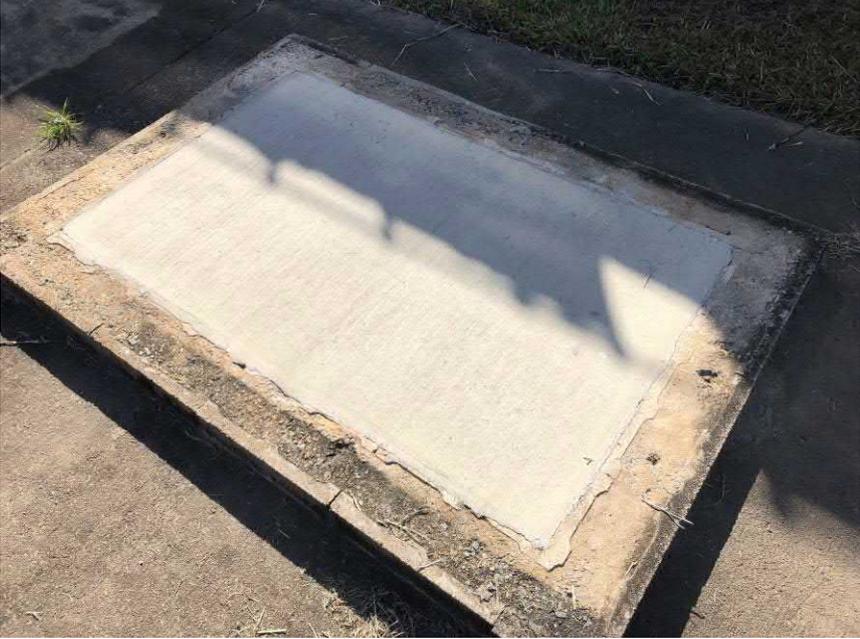
<b>Site Name:</b> QFES – Airlie Beach Fire Station	<b>Site Location:</b> 2495 Shute Harbour Road, Airlie Beach	<b>Date of Photograph:</b> 13/02/2019	<b>Project No:</b> 60595892
<b>Plate No. 6</b>

<b>Direction Photo Taken:</b> N/A			
<b>Description:</b> Case 4 Pit for drafting training located in the south-east corner of the site. Filled and sealed with concrete in 2018.

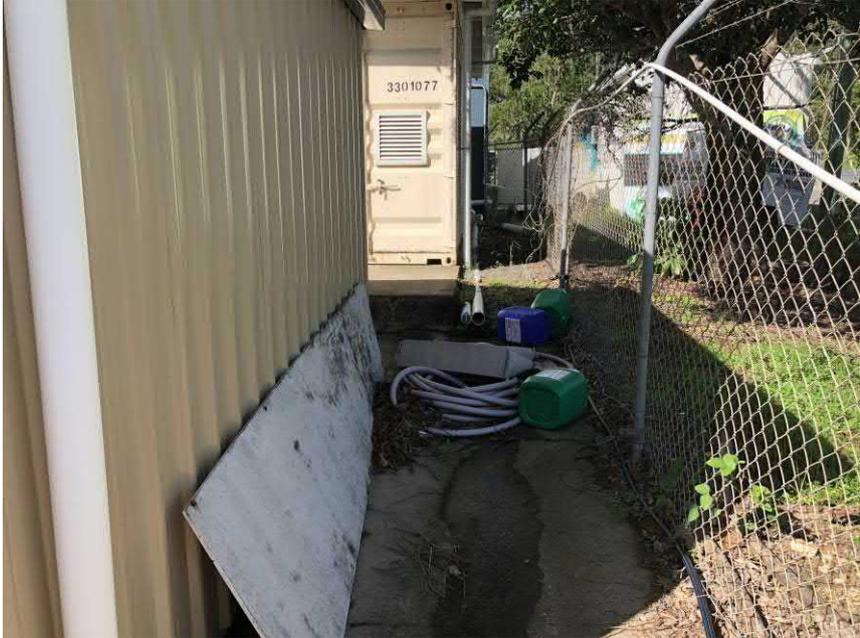
<b>Site Name:</b> QFES – Airlie Beach Fire Station	<b>Site Location:</b> 2495 Shute Harbour Road, Airlie Beach	<b>Date of Photograph:</b> 13/02/2019	<b>Project No:</b> 60595892
<b>Plate No. 7</b>

<b>Direction Photo Taken:</b> South-west			
<b>Description:</b> Miscellaneous waste between western boundary fence and the storage shed. Concrete spoon drain visible in the foreground.

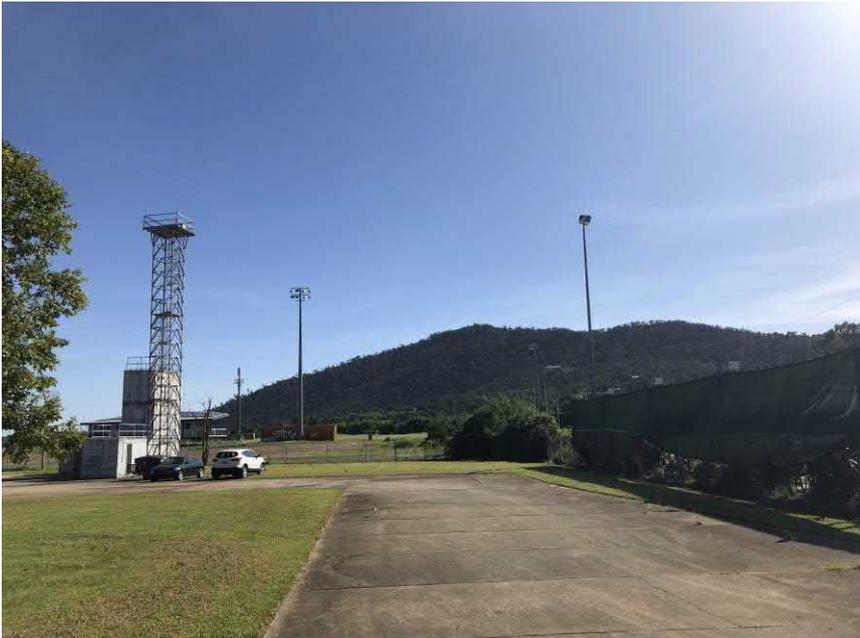
<b>Site Name:</b> QFES – Airlie Beach Fire Station	<b>Site Location:</b> 2495 Shute Harbour Road, Airlie Beach	<b>Date of Photograph:</b> 13/02/2019	<b>Project No:</b> 60595892
<b>Plate No. 8</b>

<b>Direction Photo Taken:</b> North-west			
<b>Description:</b> View along the driveway to the site with the grassed area in the background the primary area for foam training.

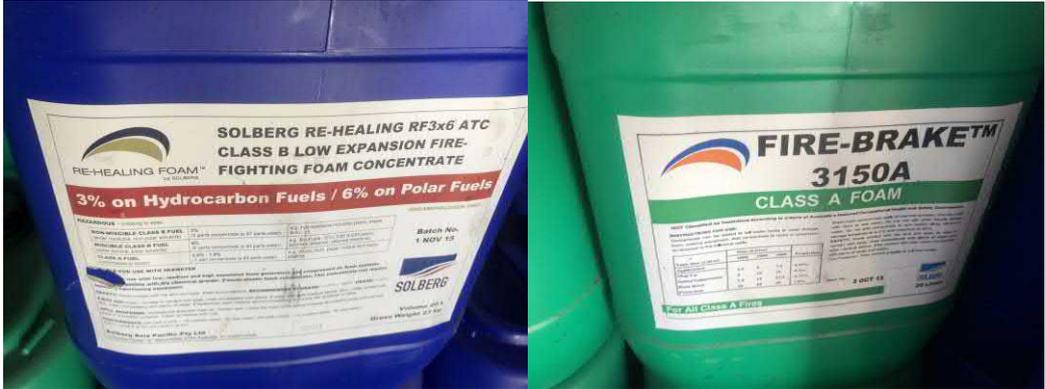
<b>Site Name:</b> QFES – Ayr Fire Station	<b>Site Location:</b> 47-49 Soper Street, Ayr, 4807	<b>Date of Photograph:</b> 13/02/2019	<b>Project No:</b> 60595892
<b>Plate No. 1</b>

<b>Direction Photo Taken:</b> N/A			
<b>Description:</b> Class A and Class B Foams stored in storage shed in the southern corner of the site.

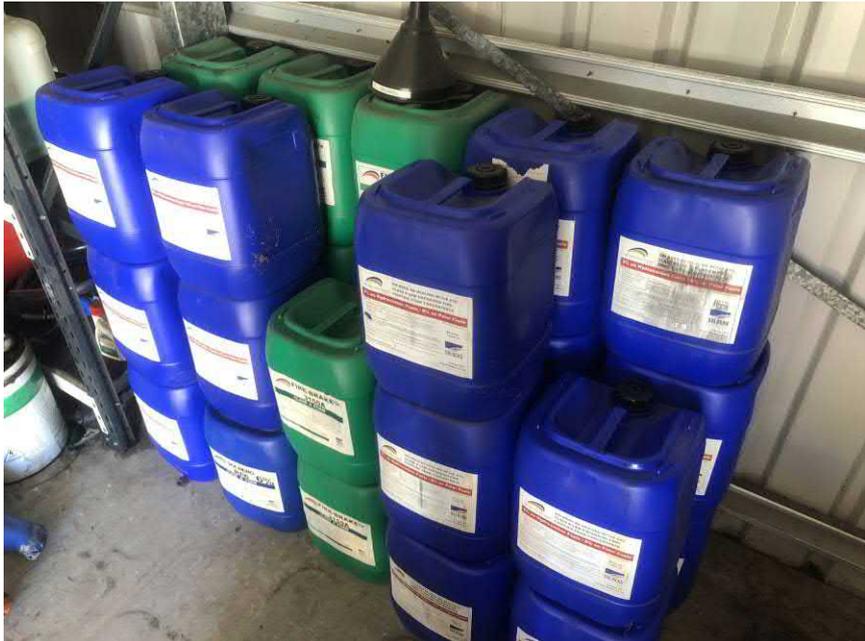
<b>Site Name:</b> QFES – Ayr Fire Station	<b>Site Location:</b> 47-49 Soper Street, Ayr, 4807	<b>Date of Photograph:</b> 13/02/2019	<b>Project No:</b> 60595892
<b>Plate No. 2</b>

<b>Direction Photo Taken:</b> N/A			
<b>Description:</b> Storage of 11 x 20L Class A drums and 17 x 20L Class B drums in a storage shed in the southern corner of the site.

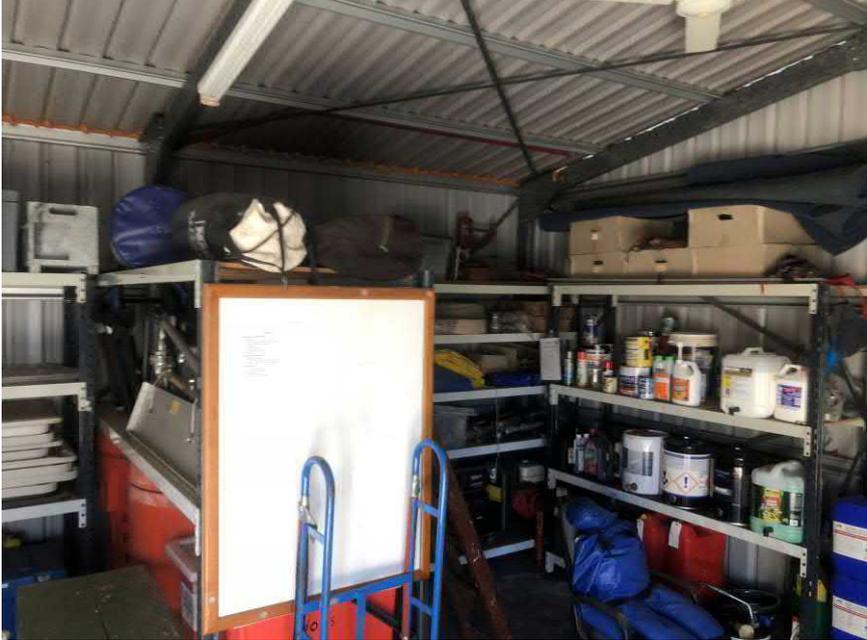
<b>Site Name:</b> QFES – Ayr Fire Station	<b>Site Location:</b> 47-49 Soper Street, Ayr, 4807	<b>Date of Photograph:</b> 13/02/2019	<b>Project No:</b> 60595892
<b>Plate No. 3</b>

<b>Direction Photo Taken:</b> N/A			
<b>Description:</b> Storage shed located in the southern corner of site, including miscellaneous fuel, oil, cleaning chemicals and foam storage.

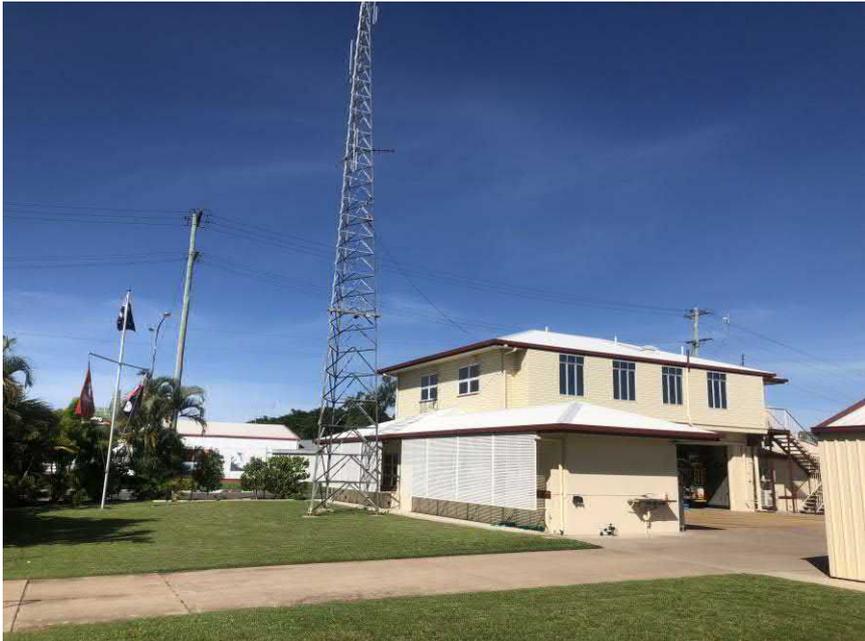
<b>Site Name:</b> QFES – Ayr Fire Station	<b>Site Location:</b> 47-49 Soper Street, Ayr, 4807	<b>Date of Photograph:</b> 13/02/2019	<b>Project No:</b> 60595892
<b>Plate No. 4</b>

<b>Direction Photo Taken:</b> North			
<b>Description:</b> Grassed area in the western portion of the site bisected by the driveway. A radio tower is located adjacent to the breathing apparatus and workshop rooms.

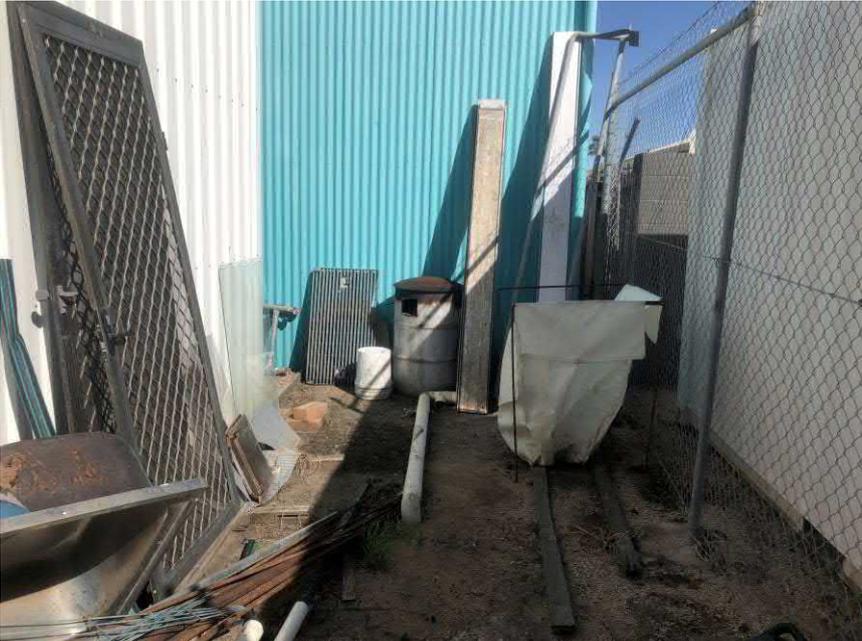
<b>Site Name:</b> QFES – Ayr Fire Station	<b>Site Location:</b> 47-49 Soper Street, Ayr, 4807	<b>Date of Photograph:</b> 13/02/2019	<b>Project No:</b> 60595892
<b>Plate No. 6</b>

<b>Direction Photo Taken:</b> South-east			
<b>Description:</b> Miscellaneous waste items between storage shed and southern site boundary.

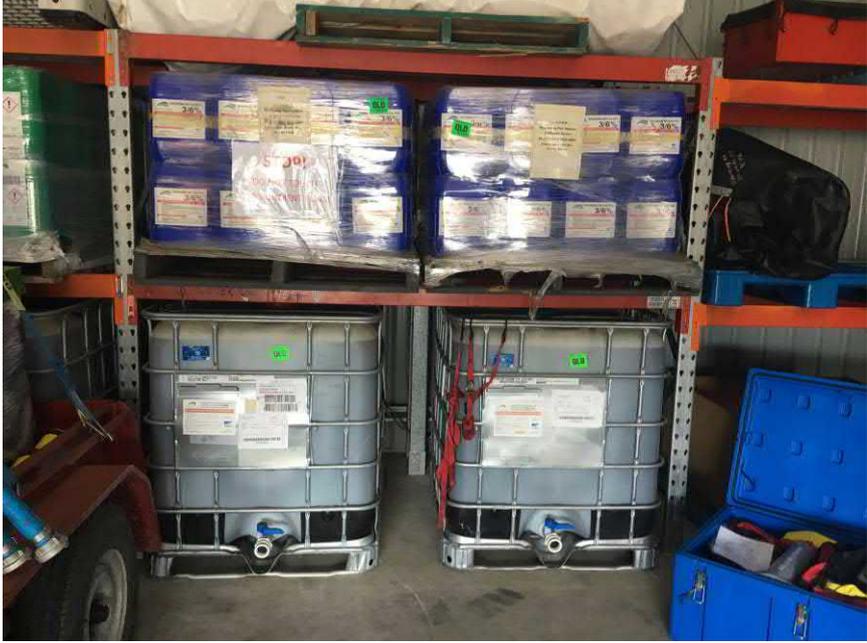
<b>Site Name:</b> QFES – Gladstone Fire Station	<b>Site Location:</b> 1 Charles Street, Gladstone, 4680	<b>Date of Photograph:</b> 29/01/2019	<b>Project No:</b> 60595892
<b>Plate No. 1</b>

<b>Direction Photo Taken:</b> N/A			
<b>Description:</b> Storage of Foam concentrate in storage shed.

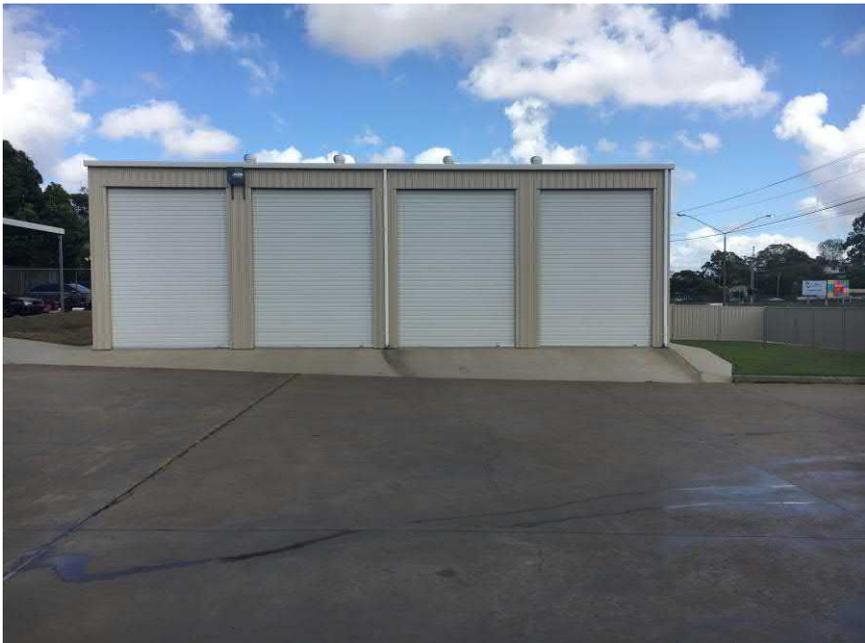
<b>Site Name:</b> QFES – Gladstone Fire Station	<b>Site Location:</b> 1 Charles Street, Gladstone, 4680	<b>Date of Photograph:</b> 29/01/2019	<b>Project No:</b> 60595892
<b>Plate No. 4</b>

<b>Direction Photo Taken:</b> West			
<b>Description:</b> Shed constructed over grassed area historically used for training purposes and subject to foam usage.

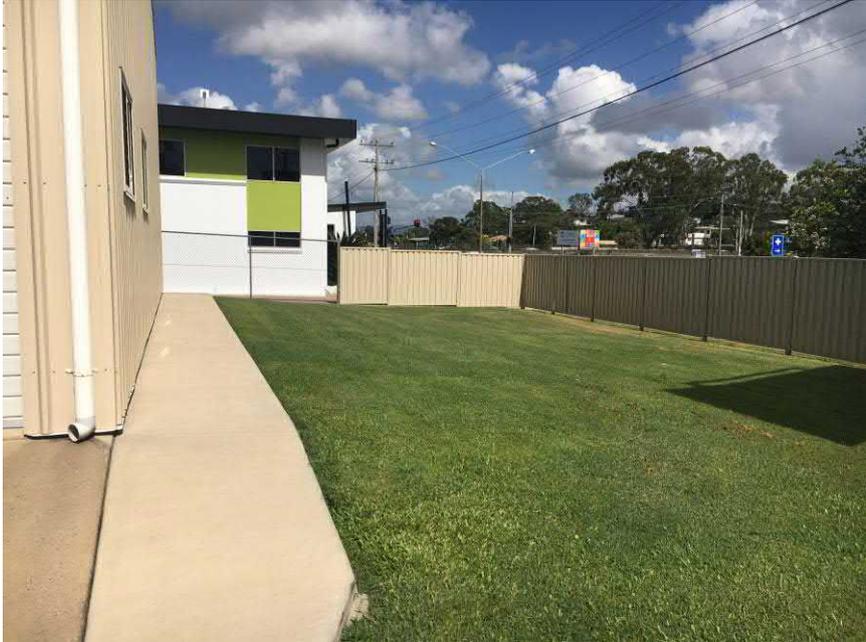
<b>Site Name:</b> QFES – Gladstone Fire Station	<b>Site Location:</b> 1 Charles Street, Gladstone, 4680	<b>Date of Photograph:</b> 29/01/2019	<b>Project No:</b> 60595892
<b>Plate No. 5</b>

<b>Direction Photo Taken:</b> West			
<b>Description:</b> Grassed area historically used for training purposes and subject to foam use. Breslin Street beyond site fence on right side of photo.

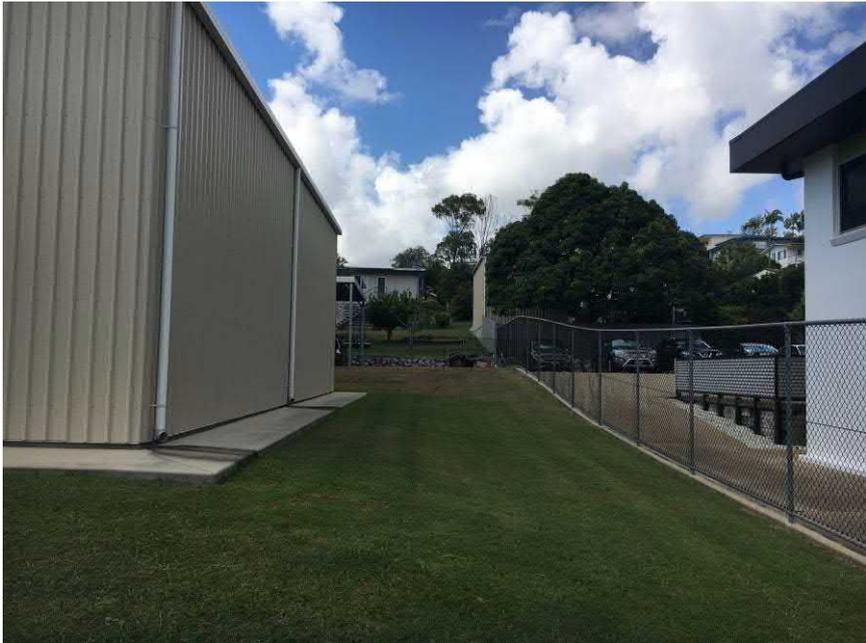
<b>Site Name:</b> QFES – Gladstone Fire Station	<b>Site Location:</b> 1 Charles Street, Gladstone, 4680	<b>Date of Photograph:</b> 29/01/2019	<b>Project No:</b> 60595892
<b>Plate No. 6</b>

<b>Direction Photo Taken:</b> South			
<b>Description:</b> Grassed area historically used for training purposes and subject to foam use. Western neighbouring property beyond site fence on right side of photo.

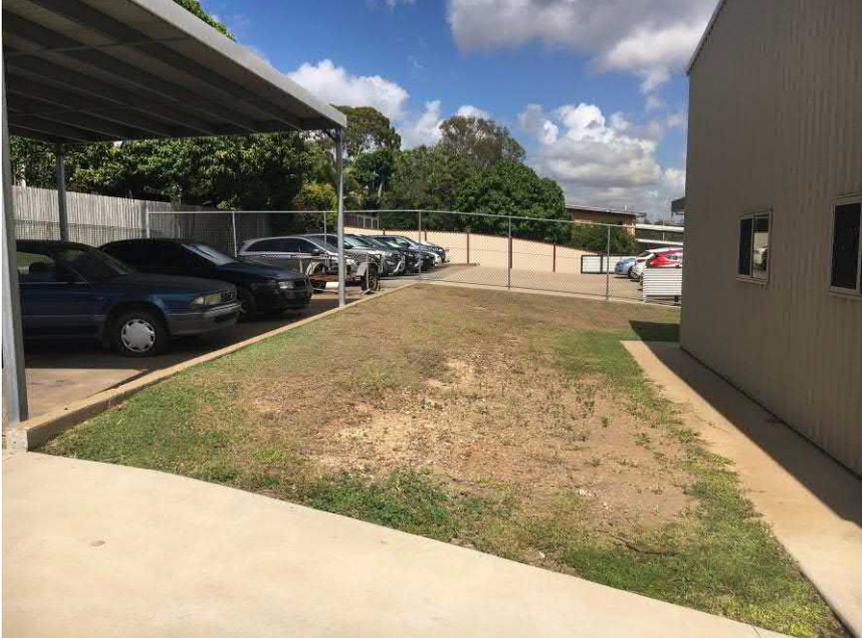
<b>Site Name:</b> QFES – Gladstone Fire Station	<b>Site Location:</b> 1 Charles Street, Gladstone, 4680	<b>Date of Photograph:</b> 29/01/2019	<b>Project No:</b> 60595892
<b>Plate No. 7</b>

<b>Direction Photo Taken:</b> West			
<b>Description:</b> Grassed area historically used for training purposes and subject to foam use.

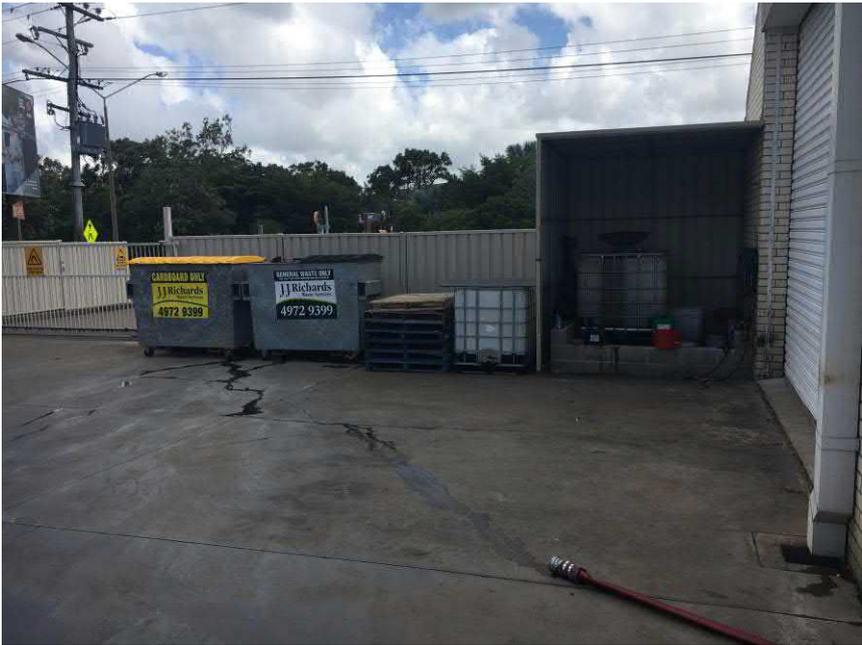
<b>Site Name:</b> QFES – Gladstone Fire Station	<b>Site Location:</b> 1 Charles Street, Gladstone, 4680	<b>Date of Photograph:</b> 29/01/2019	<b>Project No:</b> 60595892
<b>Plate No. 8</b>

<b>Direction Photo Taken:</b> North			
<b>Description:</b> Waste laydown area. Used for containment and storage and waste materials.

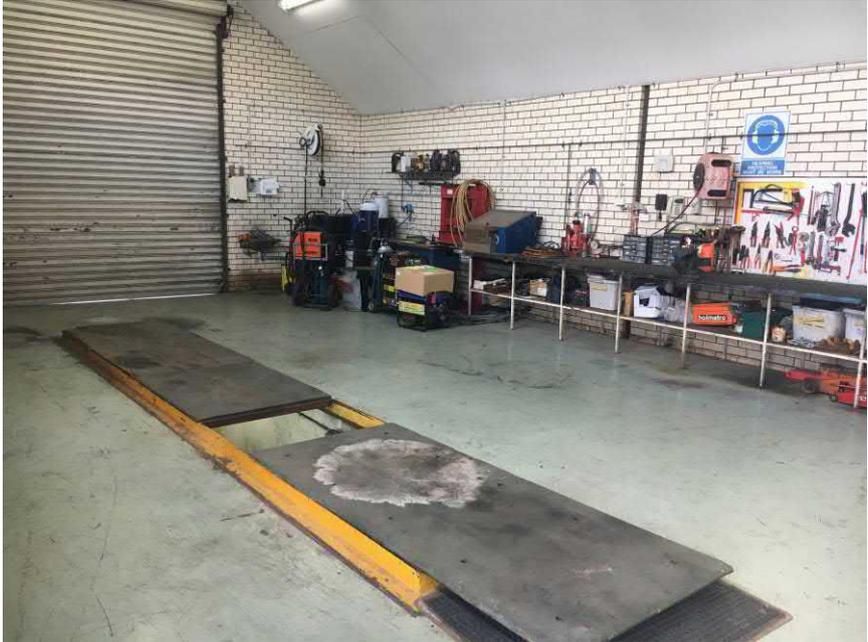
<b>Site Name:</b> QFES – Gladstone Fire Station	<b>Site Location:</b> 1 Charles Street, Gladstone, 4680	<b>Date of Photograph:</b> 29/01/2019	<b>Project No:</b> 60595892
<b>Plate No. 9</b>

<b>Direction Photo Taken:</b> South-west			
<b>Description:</b> Inside site workshop. Pit used when working under vehicle visible.

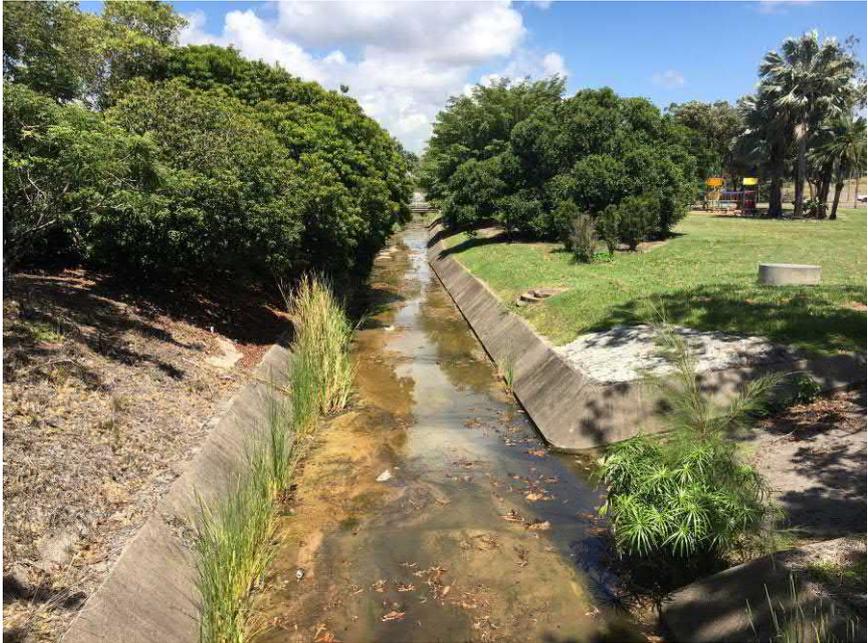
<b>Site Name:</b> QFES – Gladstone Fire Station	<b>Site Location:</b> 1 Charles Street, Gladstone, 4680	<b>Date of Photograph:</b> 29/01/2019	<b>Project No:</b> 60595892
<b>Plate No. 10</b>

<b>Direction Photo Taken:</b> East			
<b>Description:</b> Stormwater drainage channel located across Breslin Street. Receives stormwater discharge from site.

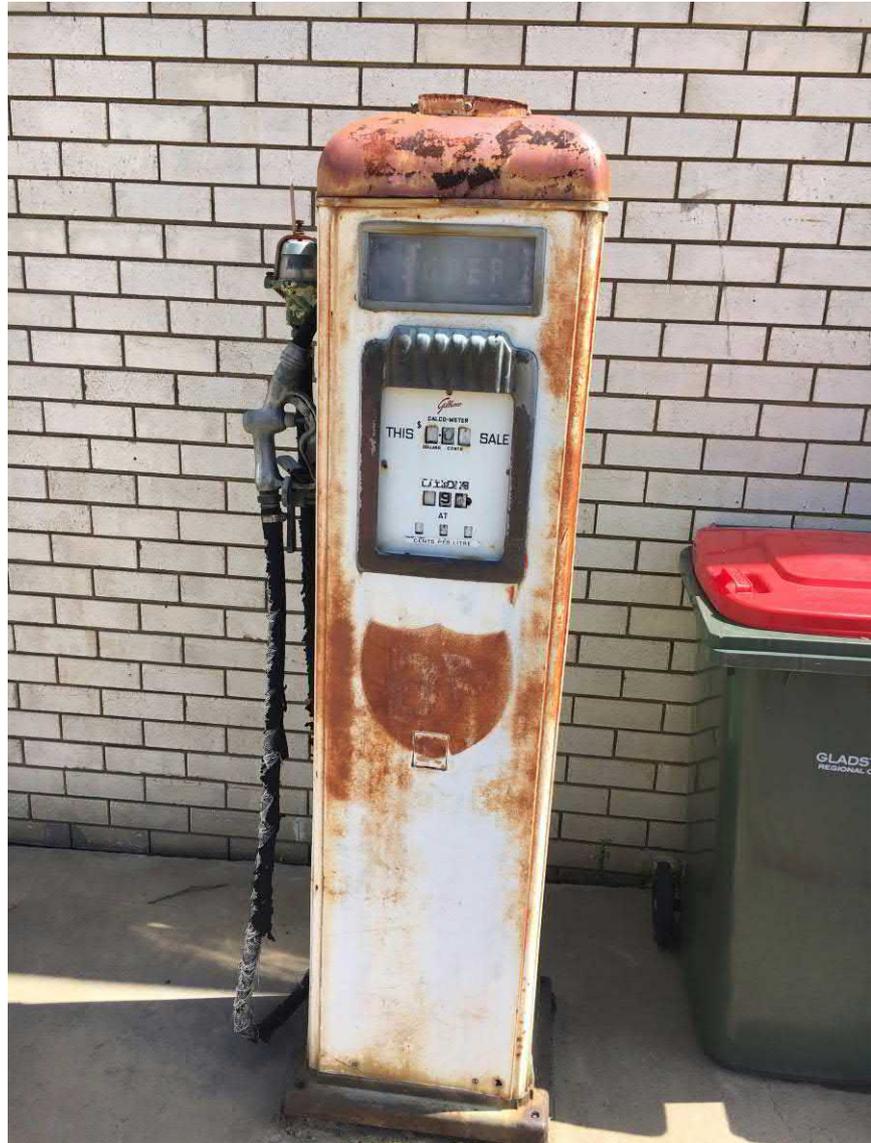
<b>Site Name:</b> QFES – Home Hill Fire Station	<b>Site Location:</b> 83 Tenth Avenue, Home Hill, 4806	<b>Date of Photograph:</b> 13/02/2019	<b>Project No:</b> 60595892
<b>Plate No. 1</b>

**Description:**  
Decommissioned bowser connected to predominantly water filled 1000L UST. Slight hydrocarbon odour remains.

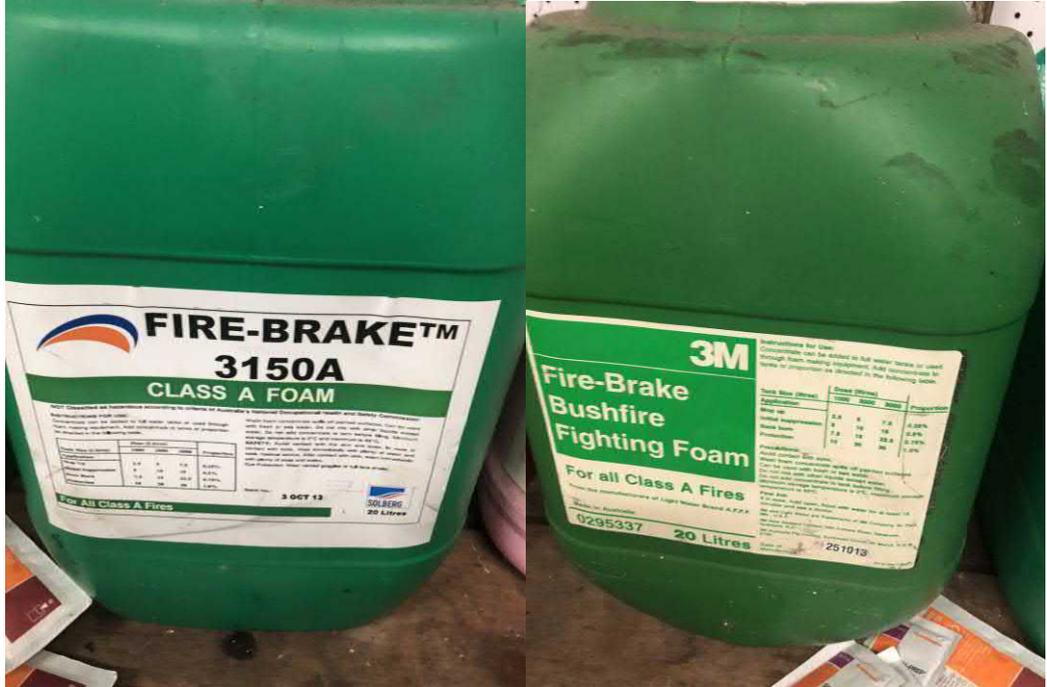
<b>Direction Photo Taken:</b> N/A			
<b>Description:</b> 20L Class A foam drums stored in the workshop/storage shed adjoining the engine room.

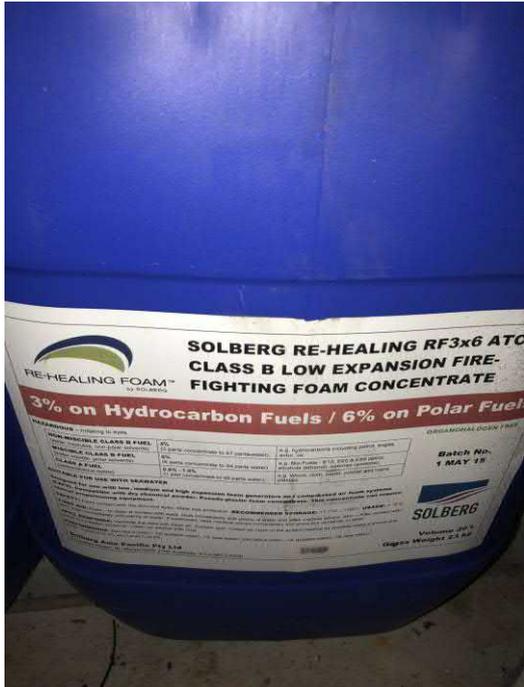
<b>Site Name:</b> QFES – Home Hill Fire Station	<b>Site Location:</b> 83 Tenth Avenue, Home Hill, 4806	<b>Date of Photograph:</b> 13/02/2019	<b>Project No:</b> 60595892
<b>Plate No. 2</b>

<b>Direction Photo Taken:</b> N/A			
<b>Description:</b> 20L Class B foam drums stored in the workshop / storage shed adjoining the engine room.

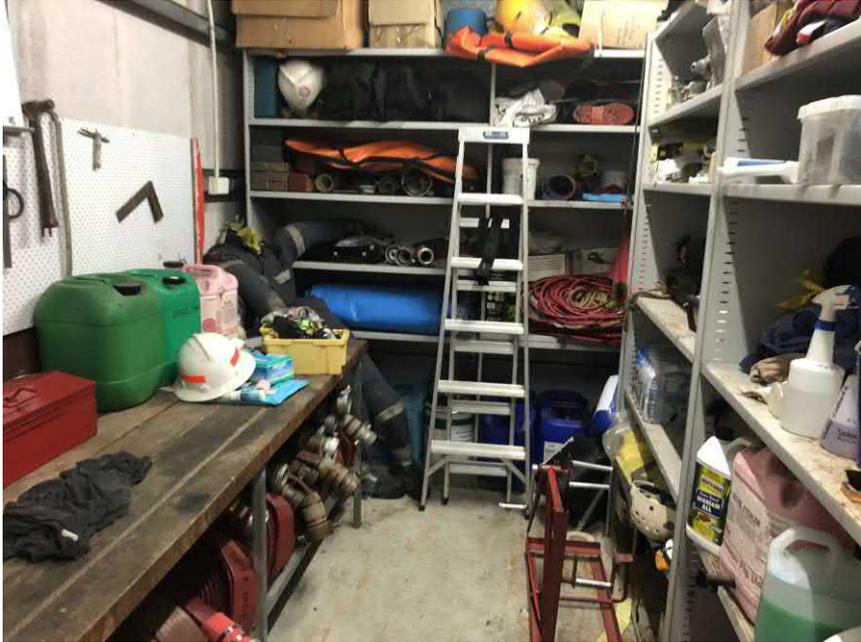
<b>Site Name:</b> QFES – Home Hill Fire Station	<b>Site Location:</b> 83 Tenth Avenue, Home Hill, 4806	<b>Date of Photograph:</b> 13/02/2019	<b>Project No:</b> 60595892
<b>Plate No. 3</b>

<b>Direction Photo Taken:</b> N/A			
<b>Description:</b> Interior of workshop / storage shed located in north-western corner of site. The area included foam and miscellaneous chemical storage.

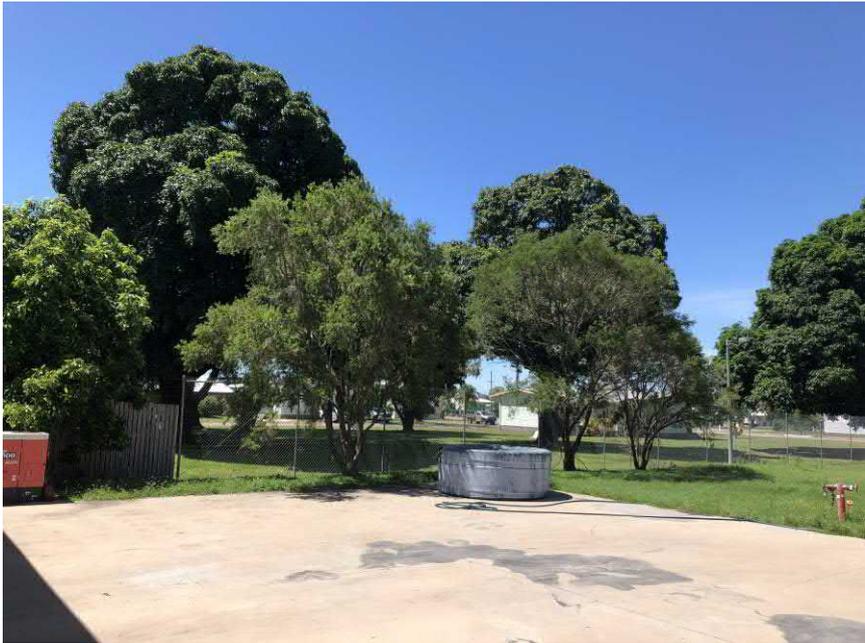
<b>Site Name:</b> QFES – Home Hill Fire Station	<b>Site Location:</b> 83 Tenth Avenue, Home Hill, 4806	<b>Date of Photograph:</b> 13/02/2019	<b>Project No:</b> 60595892
<b>Plate No. 4</b>

<b>Direction Photo Taken:</b> North			
<b>Description:</b> Concrete hardstand area outside workshop / storage, used for vehicle wash-down. AST in the background is used for drafting training.

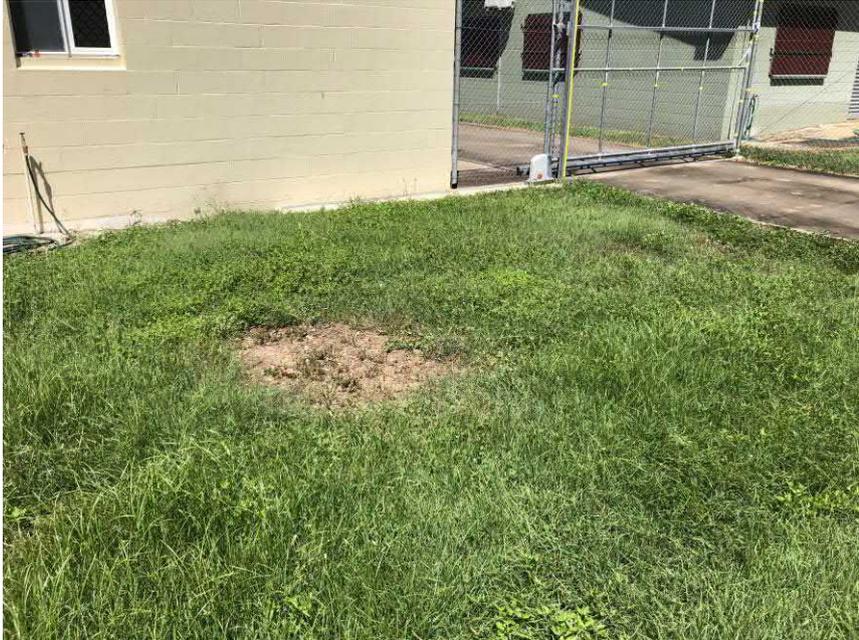
<b>Site Name:</b> QFES – Home Hill Fire Station	<b>Site Location:</b> 83 Tenth Avenue, Home Hill, 4806	<b>Date of Photograph:</b> 13/02/2019	<b>Project No:</b> 60595892
<b>Plate No. 5</b>

<b>Direction Photo Taken:</b> South-east			
<b>Description:</b> Location of decommissioned Case 4 Pit used for drafting training.

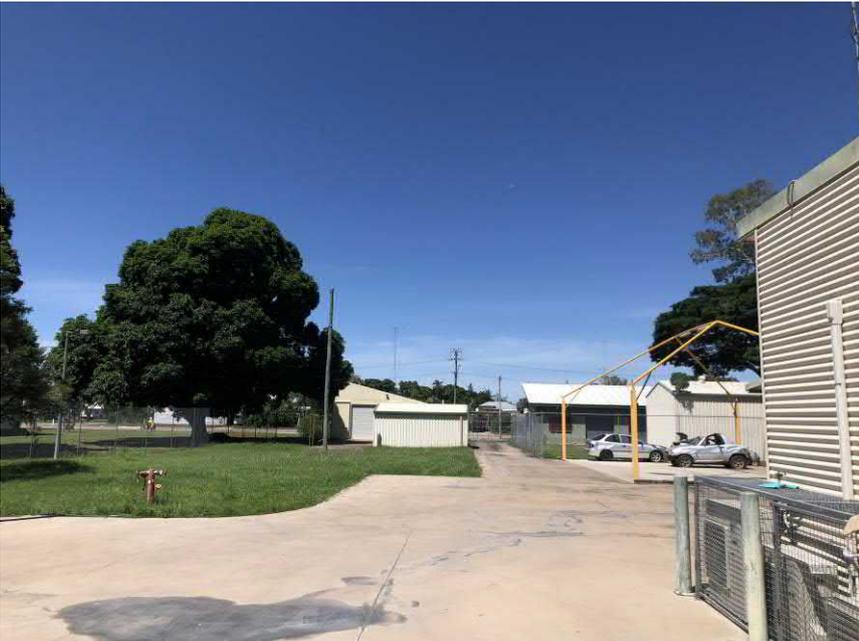
<b>Site Name:</b> QFES – Home Hill Fire Station	<b>Site Location:</b> 83 Tenth Avenue, Home Hill, 4806	<b>Date of Photographs:</b> 13/02/2019	<b>Project No:</b> 60595892
<b>Plate No. 6</b>

<b>Direction Photo Taken:</b> North-east			
<b>Description:</b> View along the length of the site towards Eleventh Avenue. The grassed area in the background is used for foam training. Note the surface stains on the concrete hardstand and surface water flow towards the east.
