# Evaluation of Concentration and Distribution of PFAS from Selected QFES Facilities

Preliminary Site Investigation & Sampling, Analysis and Quality Plan

Client: Queensland Fire and Emergency Services

02-Apr-2019

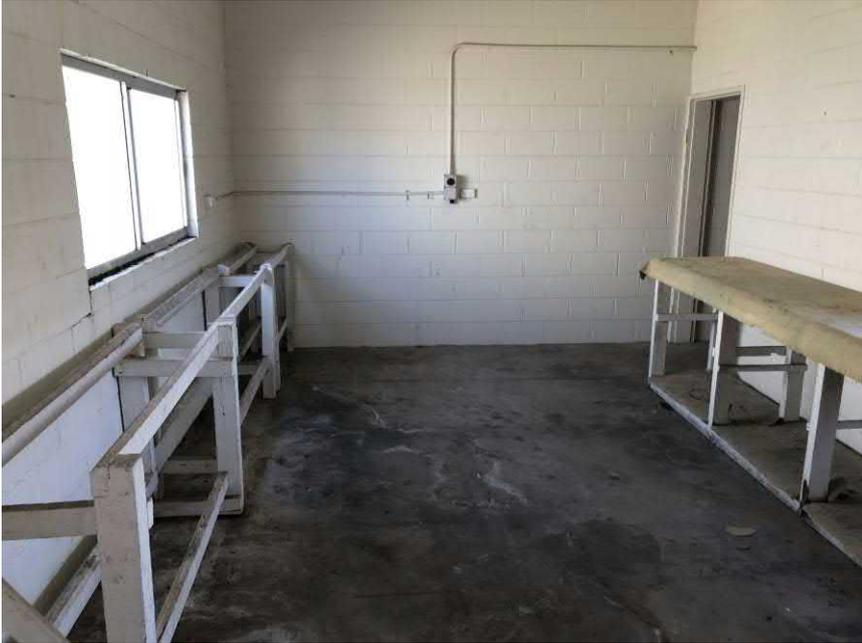
<b>Site Name:</b> QFES – Proserpine Fire Station	<b>Site Location:</b> 102 Main Street, Proserpine, 4800	<b>Date of Photograph:</b> 13/02/2019	<b>Project No:</b> 60595892
<b>Plate No. 1</b>

<b>Direction Photo Taken:</b> North			
<b>Description:</b> Interior of shed historically used for foam storage.

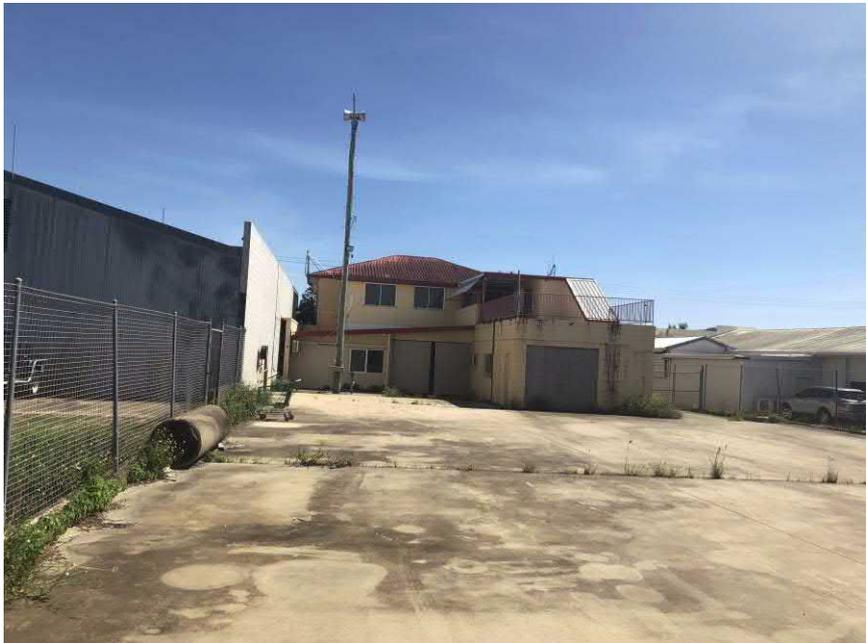
<b>Site Name:</b> QFES – Proserpine Fire Station	<b>Site Location:</b> 102 Main Street, Proserpine, 4800	<b>Date of Photograph:</b> 13/02/2019	<b>Project No:</b> 60595892
<b>Plate No. 3</b>

<b>Direction Photo Taken:</b> North			
<b>Description:</b> Site hardstand area in foreground and Fire Station in the background. Concrete hardstand was gradually sealed over time.

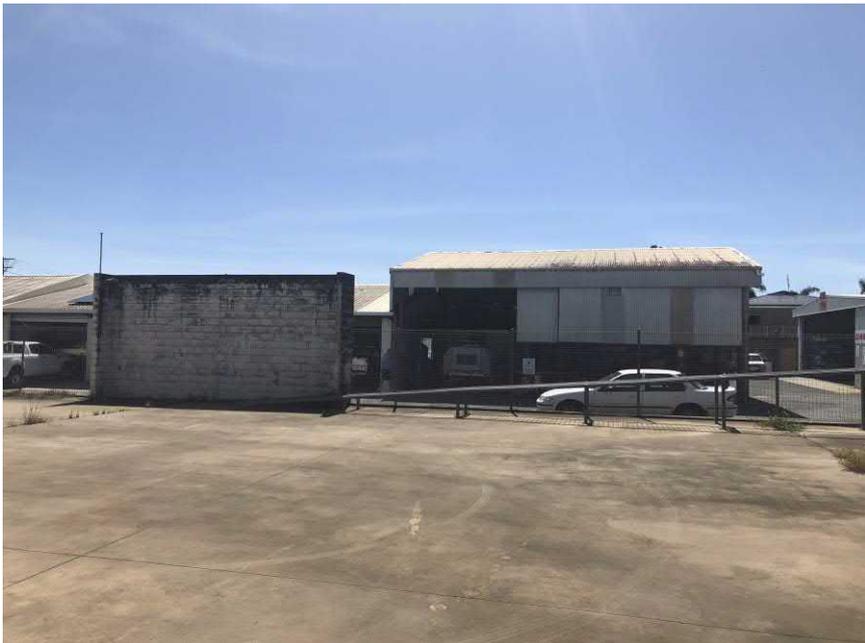
<b>Site Name:</b> QFES – Proserpine Fire Station	<b>Site Location:</b> 102 Main Street, Proserpine, 4800	<b>Date of Photograph:</b> 13/02/2019	<b>Project No:</b> 60595892
<b>Plate No. 4</b>

<b>Direction Photo Taken:</b> East			
<b>Description:</b> Remanence of a lean-to shelter which previously contained a fuel bowser and underground storage tank (unknown if it has been removed).

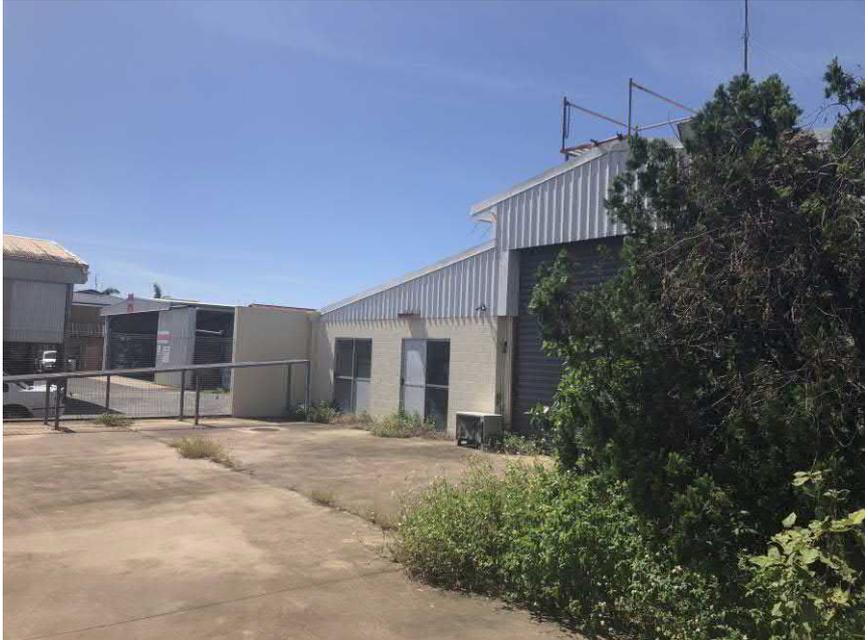
<b>Site Name:</b> QFES – Proserpine Fire Station	<b>Site Location:</b> 102 Main Street, Proserpine, 4800	<b>Date of Photograph:</b> 13/02/2019	<b>Project No:</b> 60595892
<b>Plate No. 5</b>

<b>Direction Photo Taken:</b> South-east			
<b>Description:</b> Exterior of workshop at the rear of the site. A hose drying rack is visible on the left of the photograph.

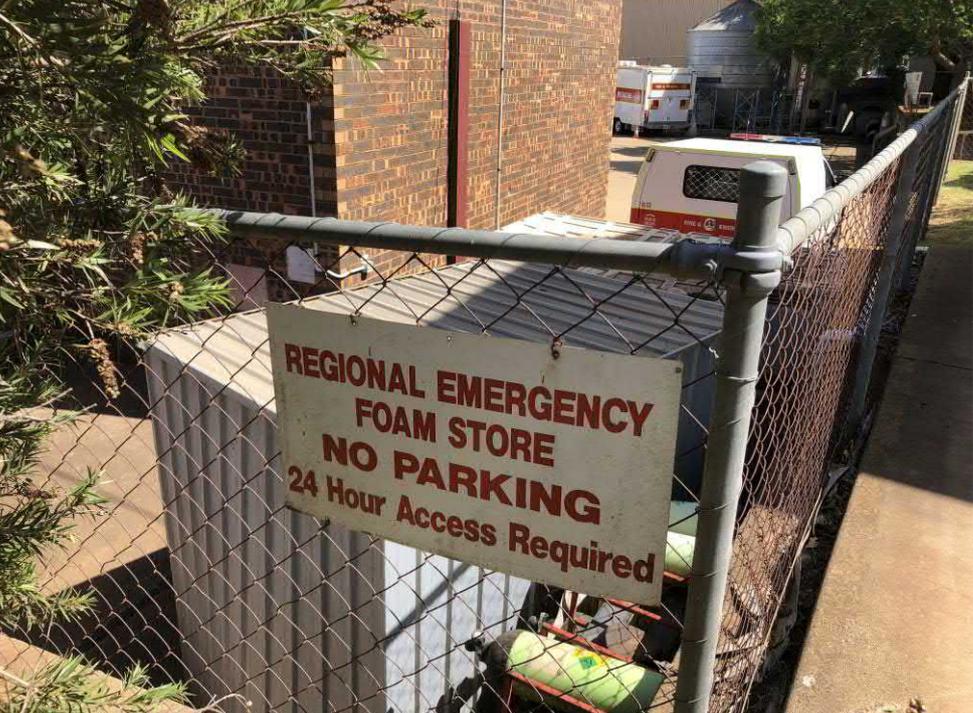
<b>Site Name:</b> QFES – Toowoomba Fire Station	<b>Site Location:</b> 201 Anzac Avenue, Toowoomba	<b>Date of Photograph:</b> 22/01/2019	<b>Project No:</b> 60595892
<b>Plate No. 2</b>

<b>Direction Photo Taken:</b> South			
<b>Description:</b> Located on southern boundary of site, at rear of foam storage building, next to driveway.

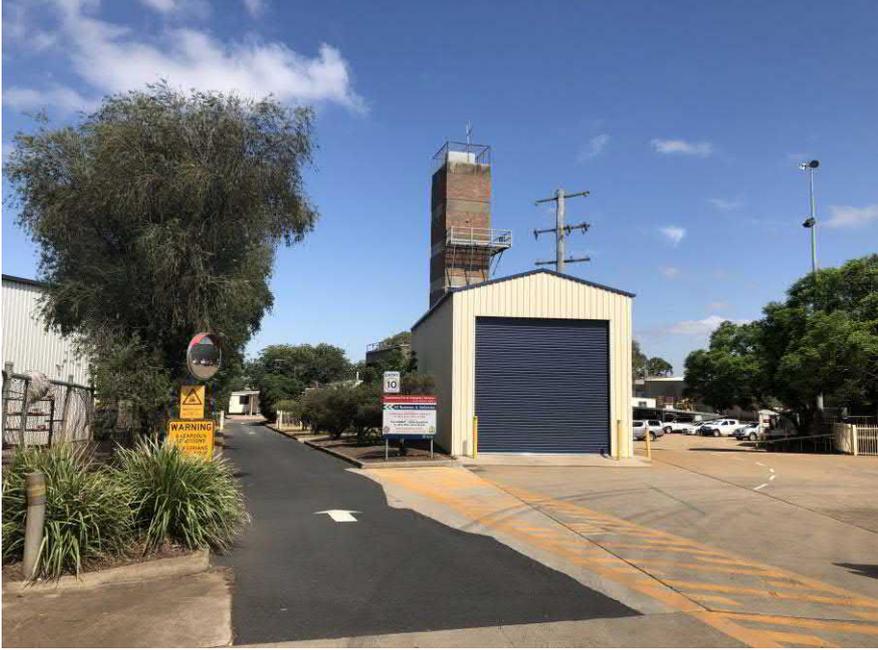
<b>Site Name:</b> QFES – Toowoomba Fire Station	<b>Site Location:</b> 201 Anzac Avenue, Toowoomba	<b>Date of Photograph:</b> 22/01/2019	<b>Project No:</b> 60595892
<b>Plate No. 3</b>

<b>Direction Photo Taken:</b> East			
<b>Description:</b> Large shed at entrance of QFES Toowoomba. Shed built in 2006 and used for foam storage. Prior to 2006, the area was covered by grass and was used to store foams.

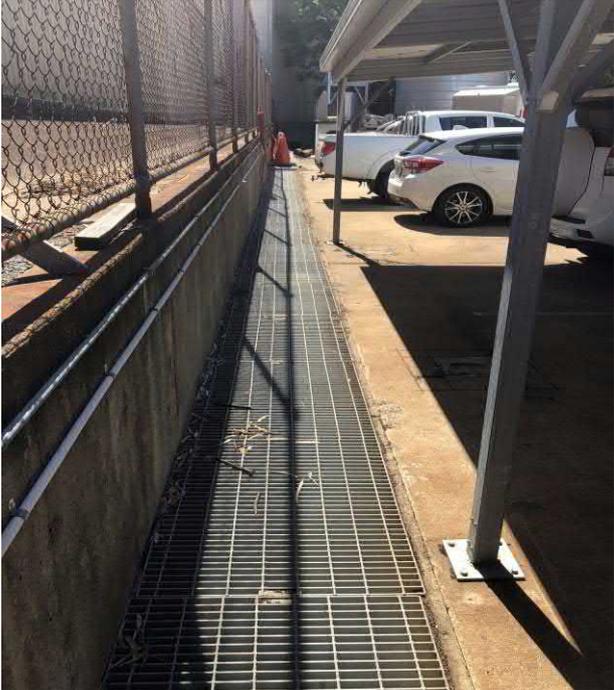
<b>Site Name:</b> QFES – Toowoomba Fire Station	<b>Site Location:</b> 201 Anzac Avenue, Toowoomba	<b>Date of Photograph:</b> 22/01/2019	<b>Project No:</b> 60595892
<b>Plate No. 4</b>

<b>Direction Photo Taken:</b> West			
<b>Description:</b> Northern boundary perimeter drain. Foam used for training exercises on the carpark drains to the north-western boundary of the site.

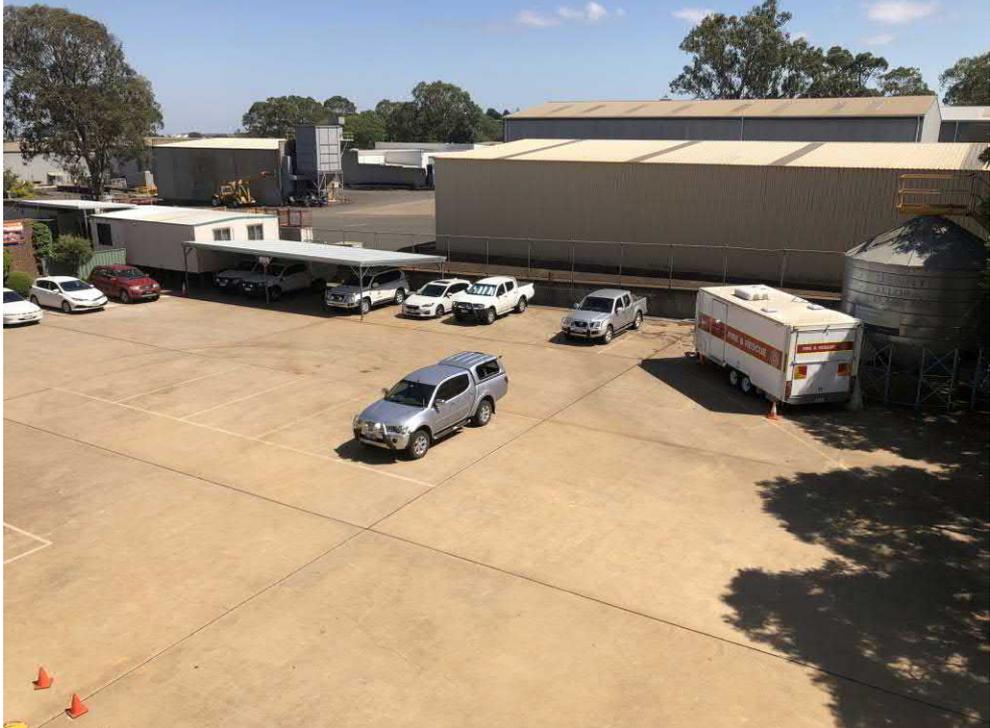
<b>Site Name:</b> QFES – Toowoomba Fire Station	<b>Site Location:</b> 201 Anzac Avenue, Toowoomba	<b>Date of Photograph:</b> 22/01/2019	<b>Project No:</b> 60595892
<b>Plate No. 5</b>

<b>Direction Photo Taken:</b> South-East			
<b>Description:</b> View of training area taken from roof of training tower. Area historically used for foam training exercises. Water drains to north-west boundary of the site, underneath carpark canopy. Confined space training area on the right side of image.

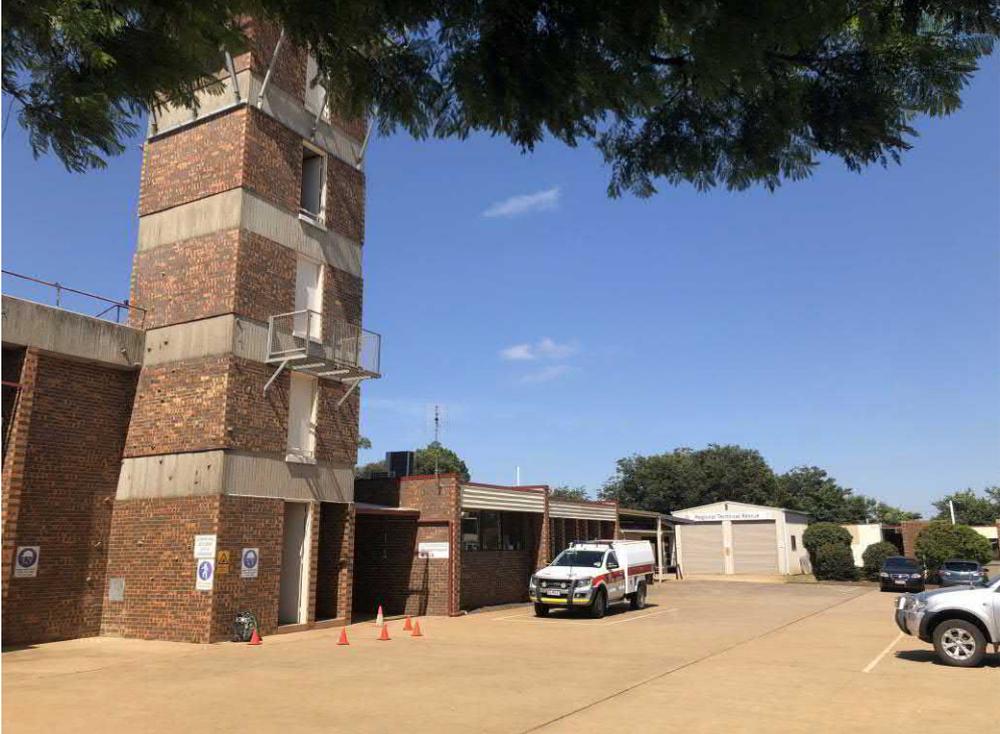
<b>Site Name:</b> QFES – Toowoomba Fire Station	<b>Site Location:</b> 201 Anzac Avenue, Toowoomba	<b>Date of Photograph:</b> 22/01/2019	<b>Project No:</b> 60595892
<b>Plate No. 6</b>

<b>Direction Photo Taken:</b> North-west			
<b>Description:</b> Training tower. Historically, smoke, water and foams were pumped into training tower for simulation exercises.

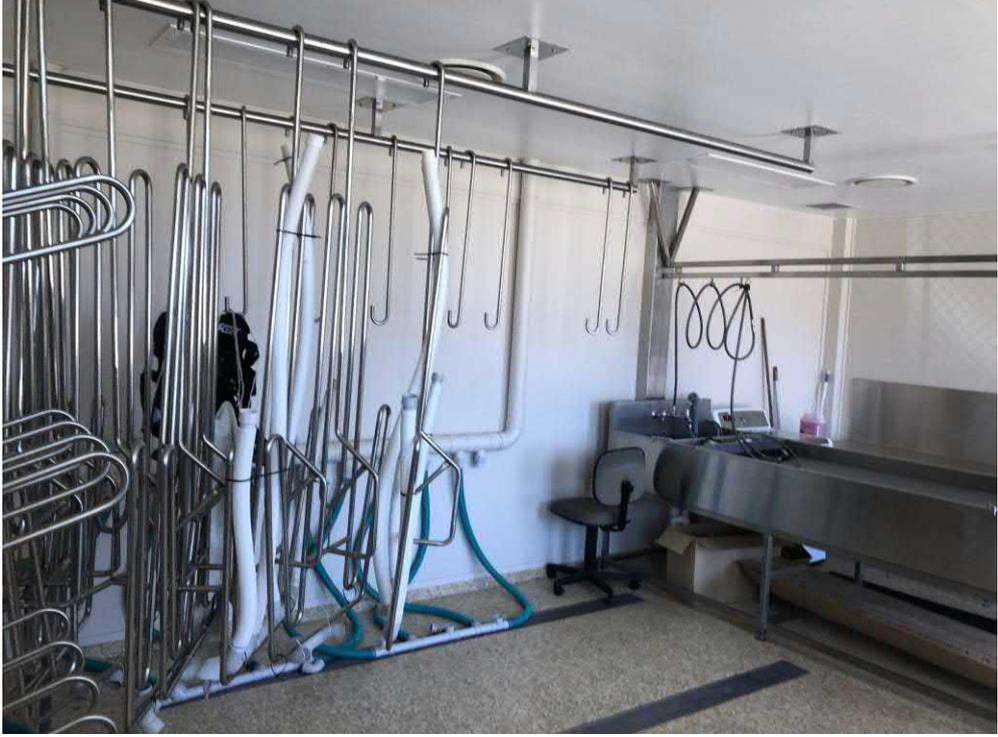
<p><b>Site Name:</b> QFES – Toowoomba Fire Station</p>	<p><b>Site Location:</b> 201 Anzac Avenue, Toowoomba</p>	<p><b>Date of Photograph:</b> 22/01/2019</p>	<p><b>Project No:</b> 60595892</p>
<p><b>Plate No. 7</b></p>

<p><b>Direction Photo Taken:</b> West</p>			
<p><b>Description:</b> Room designated for washdown of equipment used (PPE). All equipment is required to undergo decontamination procedures before being brought back to site for final wash down. Toowoomba Council monitors drain connected to washroom facility for contamination.</p>
