**AUDITOR CERTIFICATION  
REPORT & STATEMENT OF  
REASONS: HOME HILL FIRE  
STATION, 83 TENTH AVENUE,  
HOME HILL, QLD  
QUEENSLAND FIRE AND EMERGENCY  
SERVICES**

9 MARCH 2020  
719052\_HOME HILL  
VERSION 1

**Auditor Certification and Statement of Reasons: Detailed Site Investigation (DSI) of Home Hill Fire Station, 83 Tenth Avenue, Home Hill, Queensland**

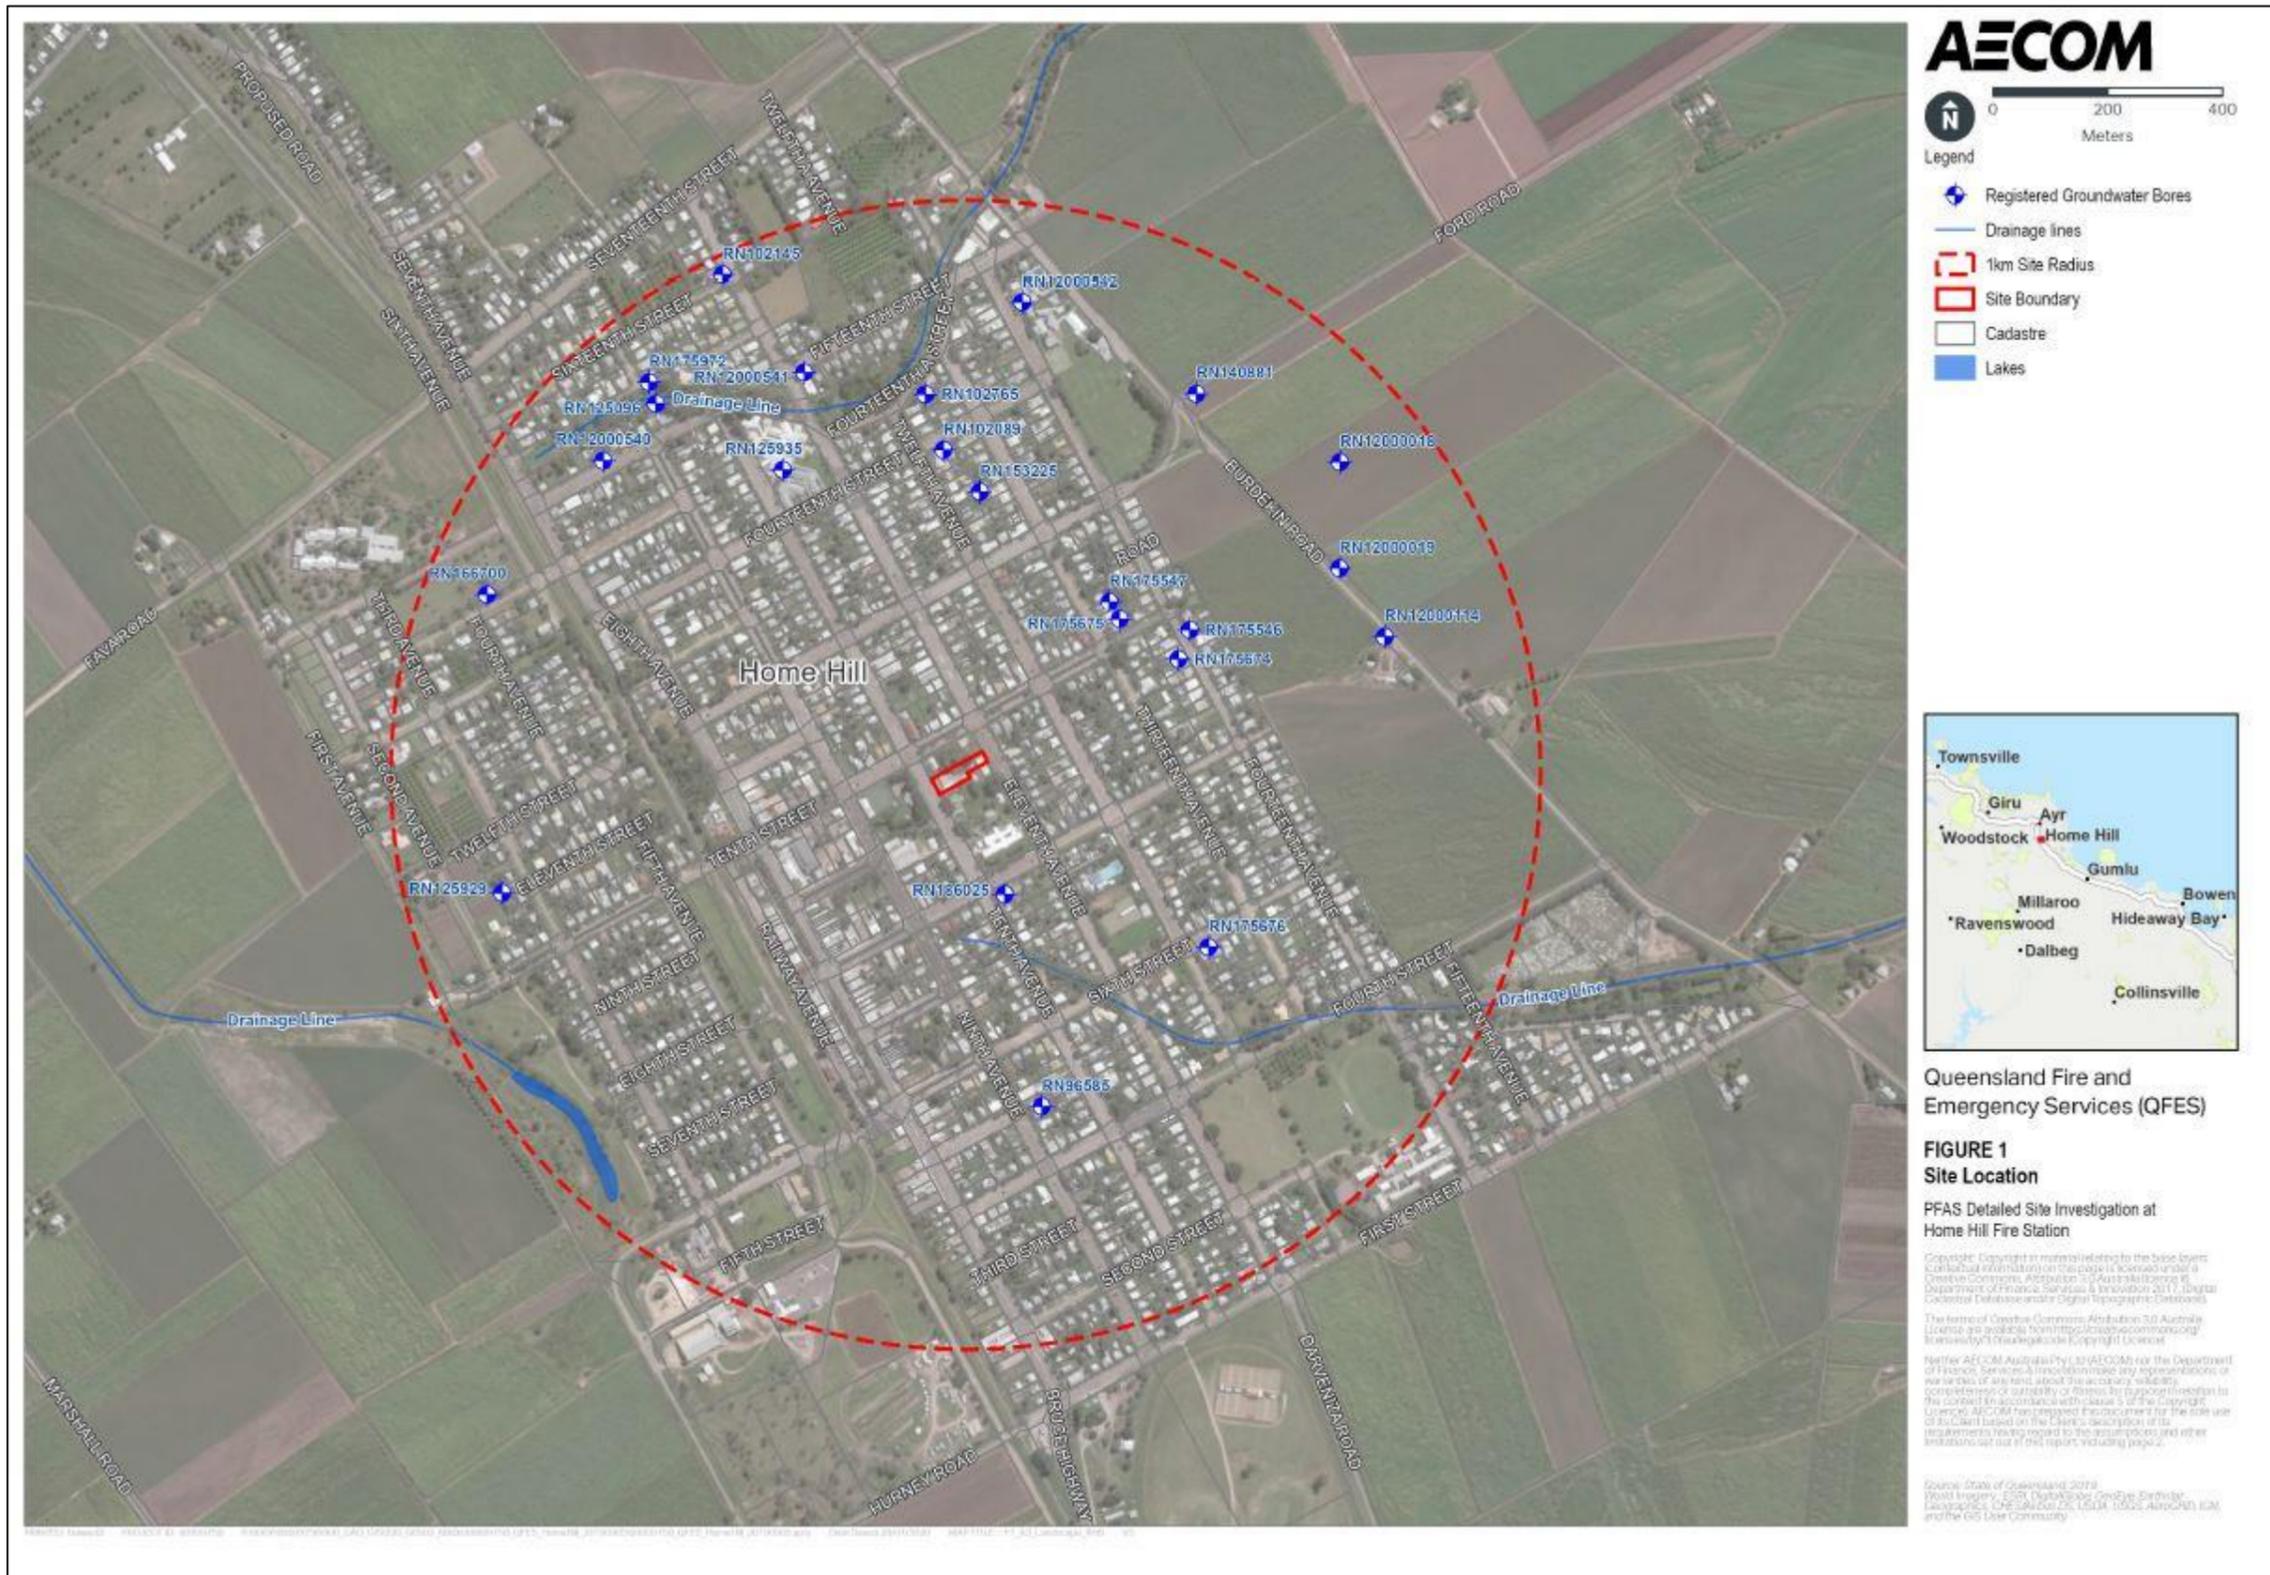
Figure 1: Site location Plan (reproduced from AECOM 2019b)

The regional locality of the site is provided on **Figure 1** and site identification details provided in **Table 1**. The subject property lot and site layout are provided on **Figures 1 and 2**.

Queensland Globe (DNRM, 2020) was used by the Auditor and AECOM (2019b) to search for registered bores in the vicinity of the site. The database indicated that there are a total of 24 bores within a 1 km radius of the site (refer **Figure 1**), of which six are located within 500 m of the site boundary.

the Burdekin River Alluvium) were identified to the north, north east and north west of the site. Refer to **Figure 1** for these features.

See **Figure 1** for these features.

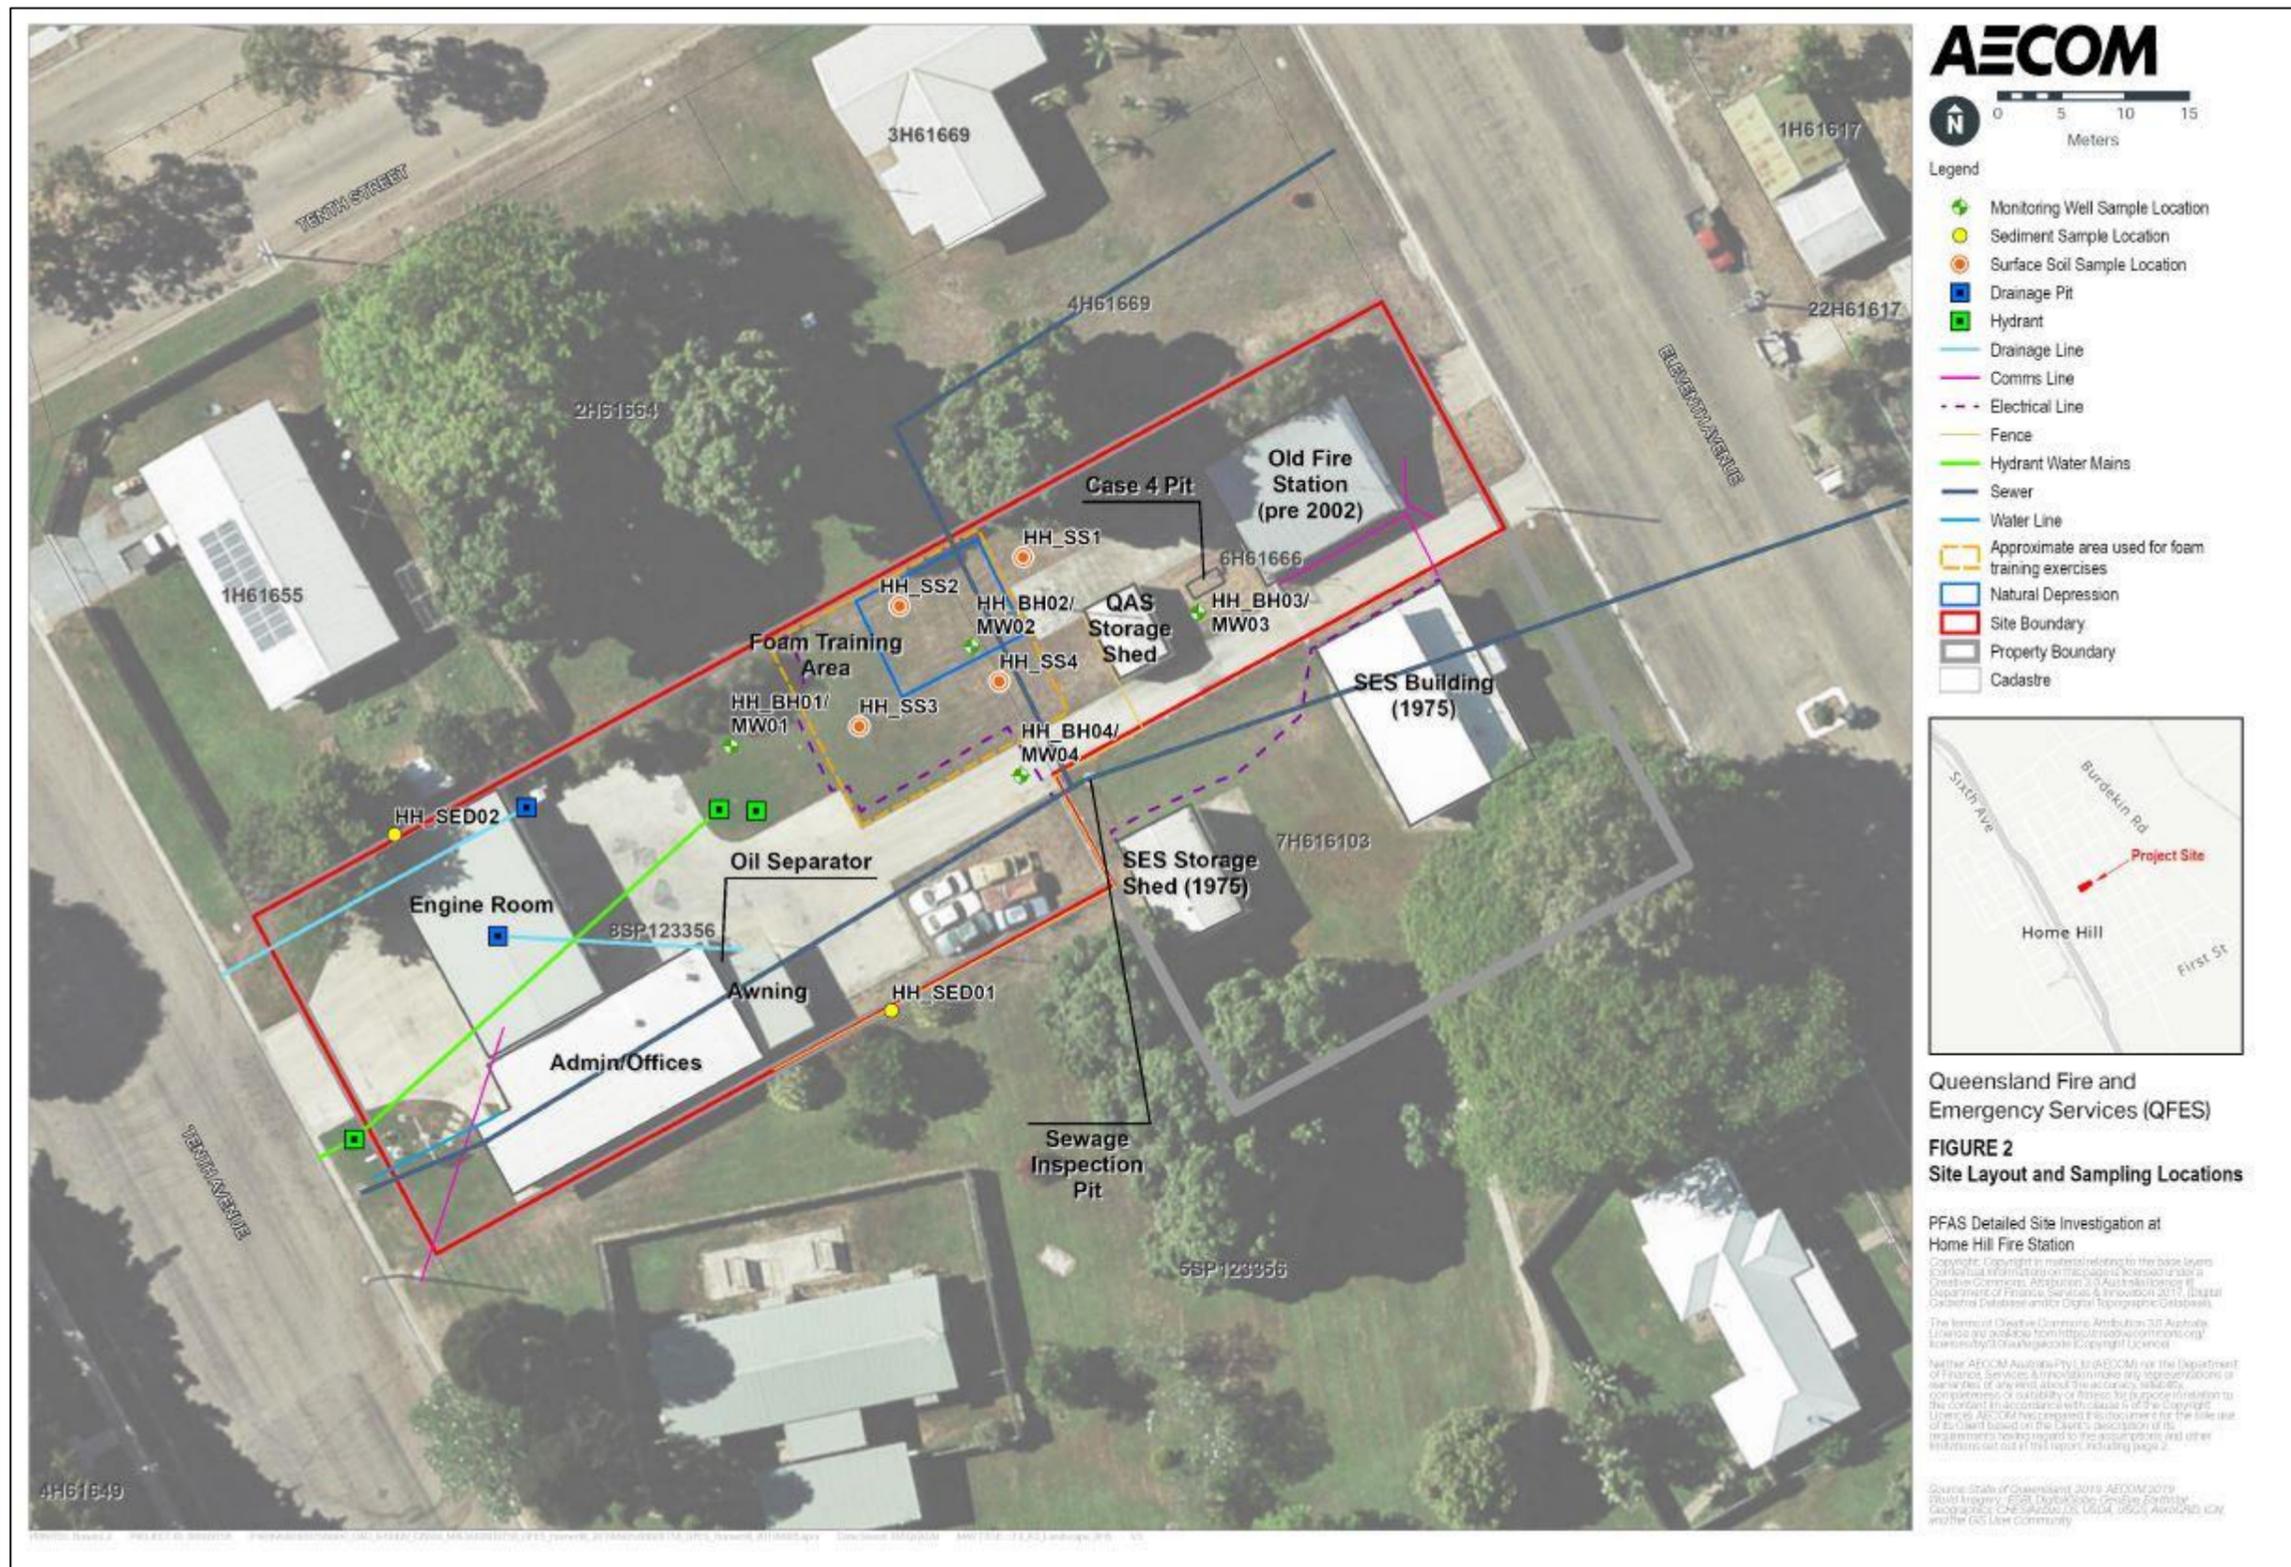
Figure 2: Site layout and sampling locations (reproduced from AECOM 2019b)

Slight depressions, which may result in accumulated water following a rainfall event, were noted along the southern boundary and in the grassed area in the centre of the site, formerly used for AFFF training exercises. Refer to **Figure 2** for these features.
