Fire hydrant test facilities

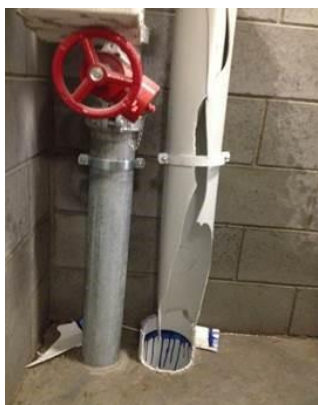
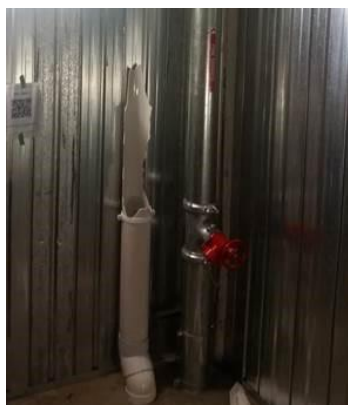
PVC pipes used as permanent drainage within fire-isolated stairs have been witnessed by QFES to initially deform, then shatter under further pressure and flow testing. This has resulted in bolts from brackets and shards of PVC becoming projectiles within the fire stair (see photos below). Due to the hazard of bursting pipes, WH&S requirements and to reduce the risk of injury occurring, QFES objects to the use of PVC test drainage pipes in fire-isolated stairwells.

Where a permanently fixed test drain is installed, this should be installed in accordance with the NCC (Plumbing Code of Australia) and AS/NZS 3500 and be sized and have a pressure rating appropriate to the pressures and flows the test drain will be subjected to.

Note 1 No PVC should be in fire exits. No PVC should penetrate a fire wall, ceiling or floor required to have a FRL. Other materials installed must comply with NCC 2019 Specification C3.15.
